ARL-TR-10065 • MAR 2025

# Failure Analysis of High-Pressure Fuel Pumps Operated with Two Jet Fuels

by Nikhil Murthy, Caleb Matzke, Caleb McCoy, and Stephen Berkebile

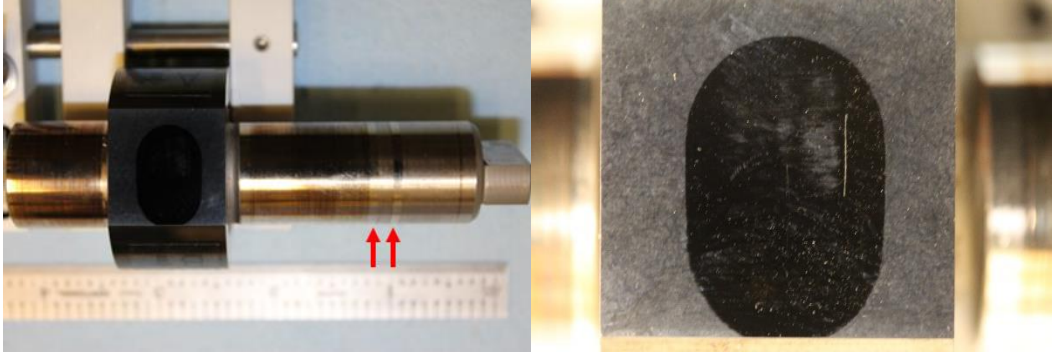
**Figure 8. Camshaft and cam ring from pump 2 (fuel 1, 1052 h).**

Wear was observed on several surfaces of pump 2, which had 1052 h of use before shutdown due to a clogged inlet metering valve (Figure 8). This clogging was not due to damage of the fuel pump, but from degraded material from the test bench redepositing within the pump.<sup>24</sup> The shaft contained two circumferential wear marks highlighted by the red arrows towards the end with the drive key at the point where the shaft interfaces with a pair of seals in the housing. Each of the flat faces on the cam ring contained an oval-shaped wear mark, which is offset towards the side of the cam ring that contacts the bucket during the intake stroke. We will refer to this side of the cam ring as the “intake side” and the other side as the “compression side.”

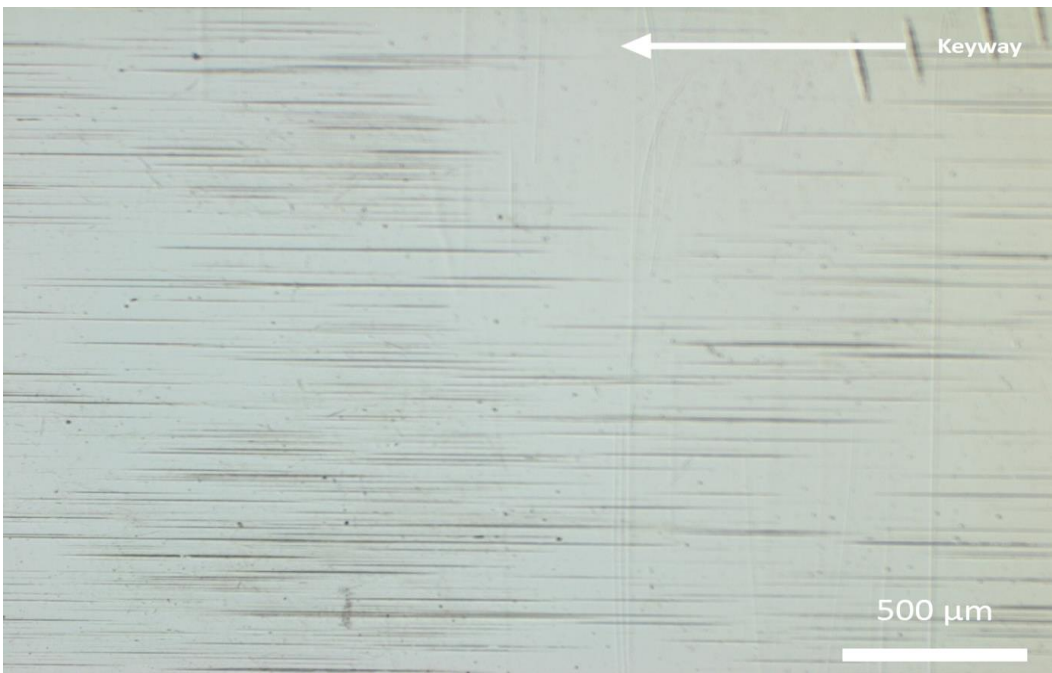
**Figure 9. Bright-field optical micrographs of one of the flat faces of the cam ring from pump 2 (fuel 1, 1052 h).**

Bright-field micrographs of the cam-ring surface are shown in Figure 9. The micrograph shows a reduction of horizontally oriented grind marks compared with the pristine pump, which is likely due to the common phenomenon of surface roughness reduction upon sliding, referred to as “run-in.” Run-in is generally beneficial to a surface in reducing friction and wear. The coating was still intact.

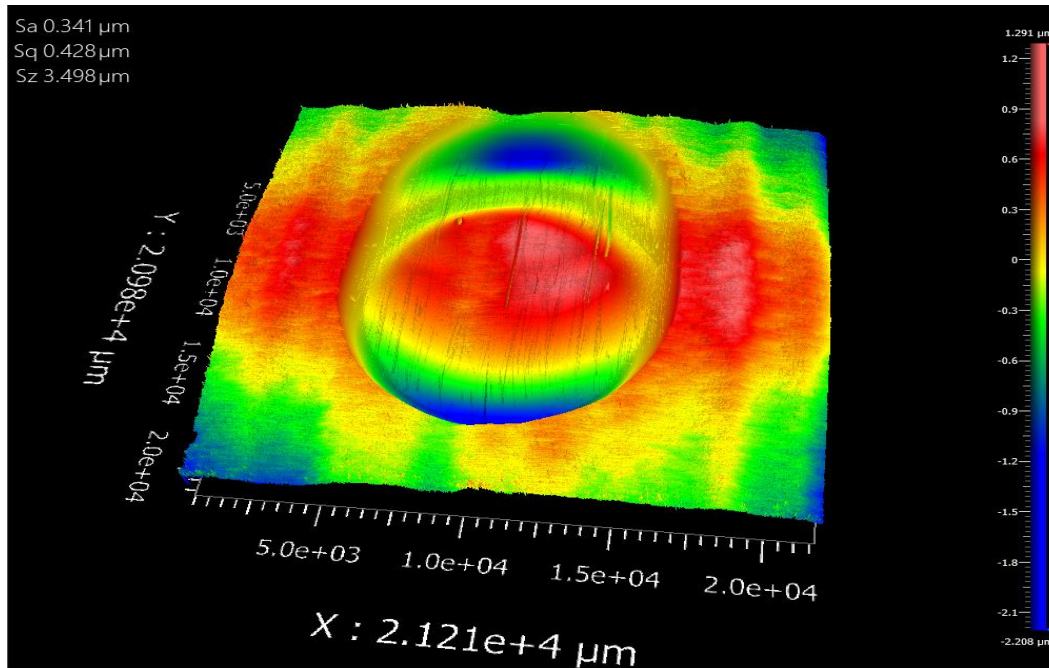
**Figure 10.** Surface profile of one of the flat faces of the cam ring from pump 2 (fuel 1, 1052 h).

The surface profile of the flat face shows that the surface maintained much of its original form with the addition of the oval-shaped wear mark described earlier (Figure 10). The wear mark was approximately 1  $\mu\text{m}$  deep along edges; however, there was a circular region centered towards the intake side within the oval-shaped mark that experienced reduced wear. The low-wear region does not extend all the way to the edge of the wear mark. We suspect that this low-wear region is caused

by rocking motion of the bucket during the pumping cycle. It was observed that the axes of the pump bores are approximately 1.4 mm offset from the axis of the camshaft. This offset allows the cam ring to experience lower torques than it would without an offset, but it also means that the direction of the torque applied to the cam ring alternates. We suspect that the alternating torque causes a rocking motion of the cam ring causing the heaviest load to alternate between the two leading/following edges of the bucket during sliding. We can see evidence of this rocking motion by the reduced wear we observe from the circular region within the wear mark where the bucket would have shifted from one edge to the other. Lastly, increased wear was observed at the ends of the wear scar, which may have been caused by the low hydrodynamic fluid protection at the turnarounds where the entrainment speed approaches zero. The roughness of the cam-ring surface was  $S_a = 49 \pm 24$  nm inside of the worn area. The decrease in roughness from the pristine surface was likely due to run-in.

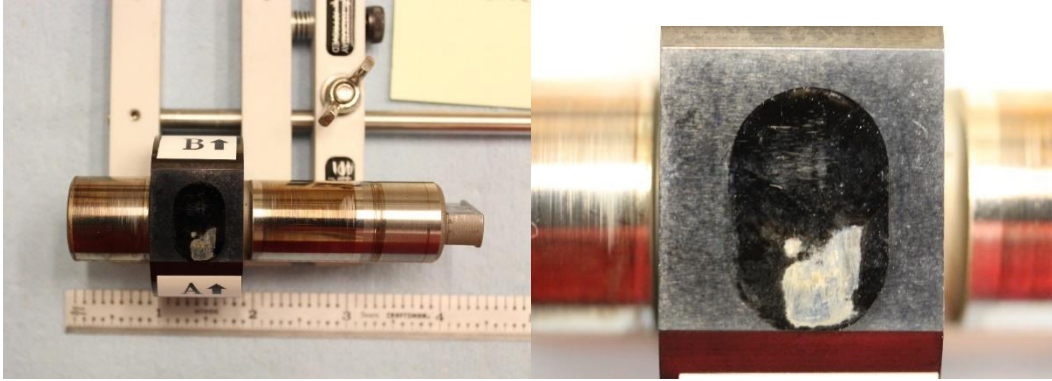
**Figure 11. Camshaft and cam ring from pump 3 (fuel 1, 1800 h).**

Pump 3 was operated without decrease in function for 1800 h. The camshaft and cam ring from pump 3 exhibited many of the same wear patterns as pump 2 but also showed signs of coating wear. As shown in Figure 11, the coating was worn away on the intake side of the wear mark, exposing the bare steel surface.

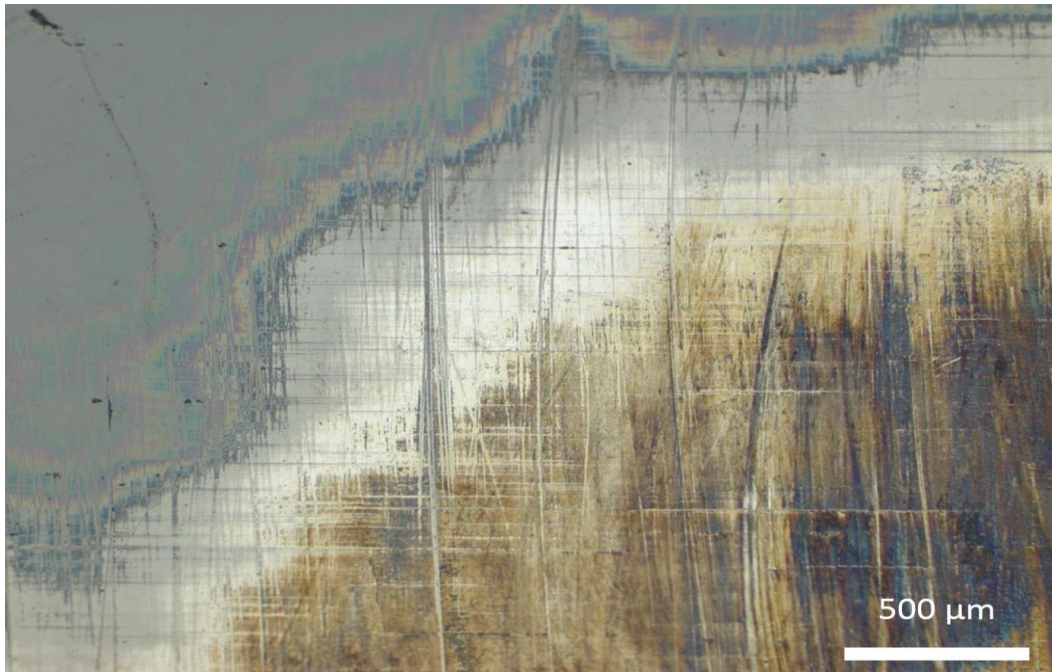
**Figure 12. Bright-field optical micrograph of one of the flat faces of the cam ring from pump 3 (fuel 1, 1800 h).**

The wear of the coating can be seen in detail in the optical micrograph of the cam-ring surface shown in Figure 12. The upper left corner of the micrograph shows the coating, while the lower right corner has the exposed steel. There was a gradual transition between the two regions, suggesting that coating was worn away as opposed an abrupt transition resulting from chipping or delamination. There was evidence of substantially more abrasive wear and a dark-brown appearance where the coating was worn.

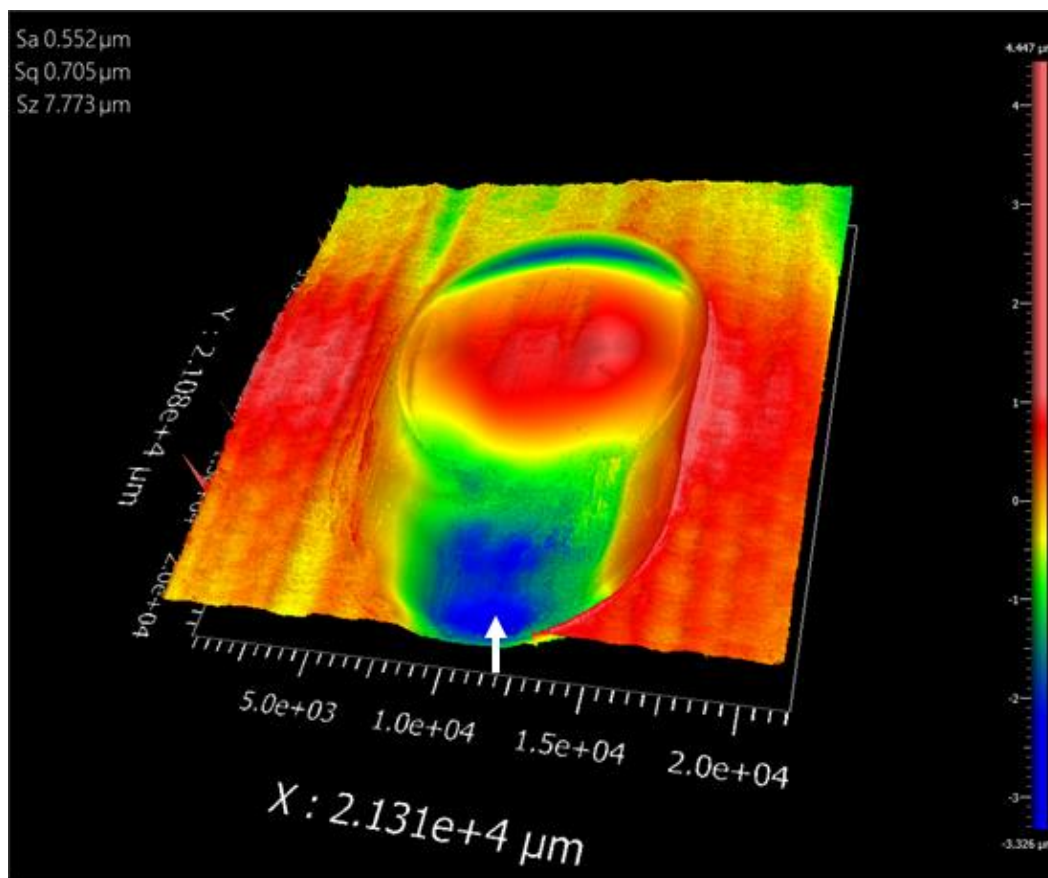
**Figure 13.** Surface profile of one of the flat faces of the cam ring from pump 3 (fuel 1, 1800 h).

The surface profile of the pump 3 cam ring (Figure 13) is similar to pump 2 in that it has the large oval shape with a central circular patch with less wear. The main difference is that pump 3 has a rougher surface near and around the area where the coating was worn. We can see a deeply worn area shown in blue in Figure 13 that matches the shape of the steel patch in Figure 11. The roughness of the cam-ring surface was  $S_a = 56.2 \pm 43$  nm.

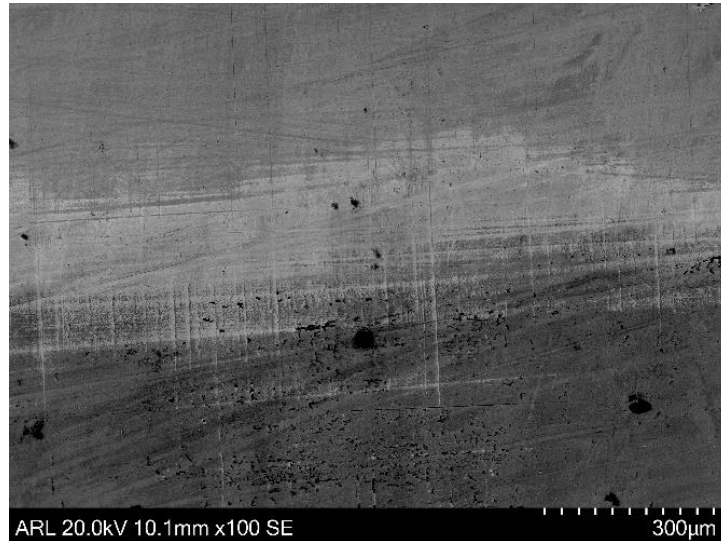
**Figure 14.** SEM micrograph taken with SE detector of the cam ring from pump 3 (fuel 1, 1800 h).

The worn area of the pump 3 cam ring was observed with both SEM (Figure 14) revealing three layers material. The regions in the SEM micrograph—starting from top to bottom—are the main coating (grey), the coating bond layer (light grey) and the exposed steel (dark grey). The EDS spectra (Figure 15) shows that the major elements present in this micrograph are carbon, tungsten, iron, oxygen, and chromium. The steel was predominantly iron but also contained oxygen, suggesting oxidation of the steel. Chromium was also present in small amounts. Chromium is a common additive for low-alloy tool steel such as AISI 52100. Moving up into the bond layer, there was a large amount of tungsten but also a small increase in the chromium concentration. This may be due to chromium migrating to the surface during the coating process, but it is more likely due to chromium used as a bonding layer. Lastly, carbon was the main contributor to the main coating. Tungsten was also observed; however, because of the low surface sensitivity of EDS, it is not possible to tell whether this is from the main coating or the bond layer. Small amounts of silver were observed in the spectra, but the quantity was too low to determine the location. Since the silver was present in high quantities in the pristine pump (Figure 5) where the coating was thicker, it is hypothesized that the silver

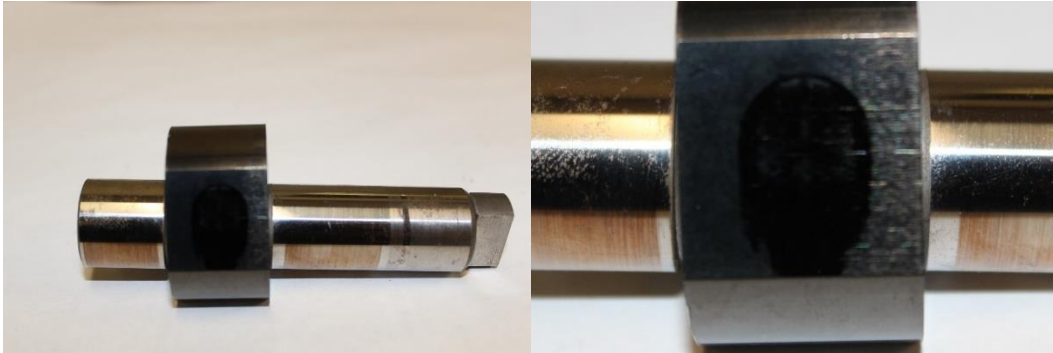
**Figure 16. Camshaft and cam ring from pump 5 (fuel 2, 476 h).**

Pump 4 ran for 476 h before a decrease in flow occurred beyond the stop criterium due to seizure of a plunger in the cylinder. Compared with pumps 2 and 3, pump 4 appeared to have less wear of the coating on the cam ring (Figure 16). The oval-shaped wear scar was fainter and there was no exposed steel. Wear marks were still seen on the camshaft.

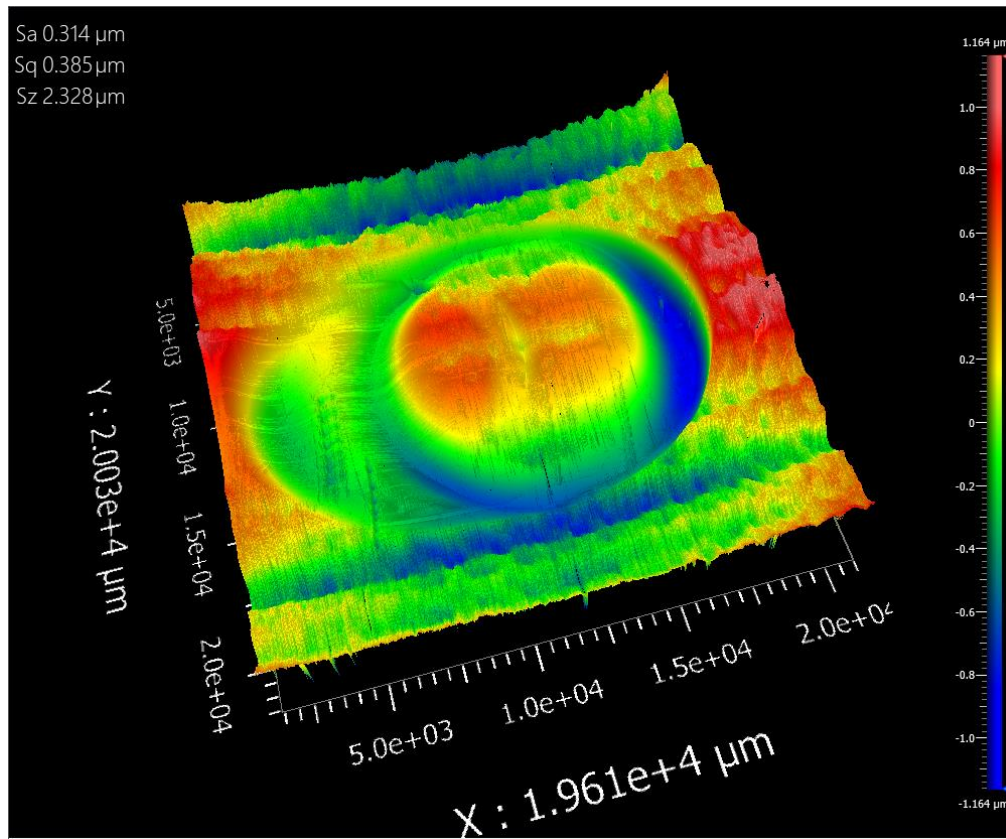
**Figure 18.** Surface profile of one of the flat faces of the cam ring from pump 4 (fuel 2, 476 h).

The surface profile of the pump 4 cam ring (Figure 18) had some wear on the region contacting the bucket similar to the wear pattern seen in pump 2. The difference in roughness was minor compared to the pristine pump. The roughness of the cam-ring surface was  $S_a = 73 \pm 10$  nm.

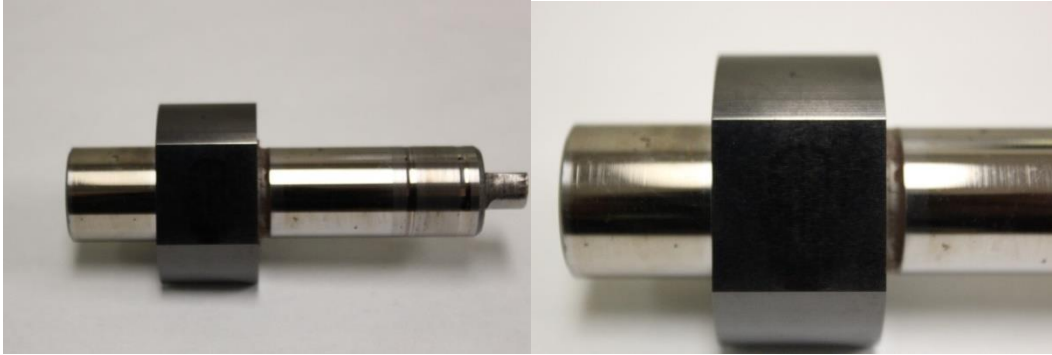
**Figure 19. Camshaft and cam ring from pump 5 (fuel 2, 1200 h).**

Pump 5 ran for 1200 h before a decrease in flow occurred beyond the stop criterium due to seizure of a plunger in the cylinder. As seen in Figure 19, pump 5's camshaft had the two wear marks from the seals and the cam ring had the oval-shaped wear mark, similar to the other pumps. The appearance was similar to pump 4 where little wear was observed and the wear scar was faint.

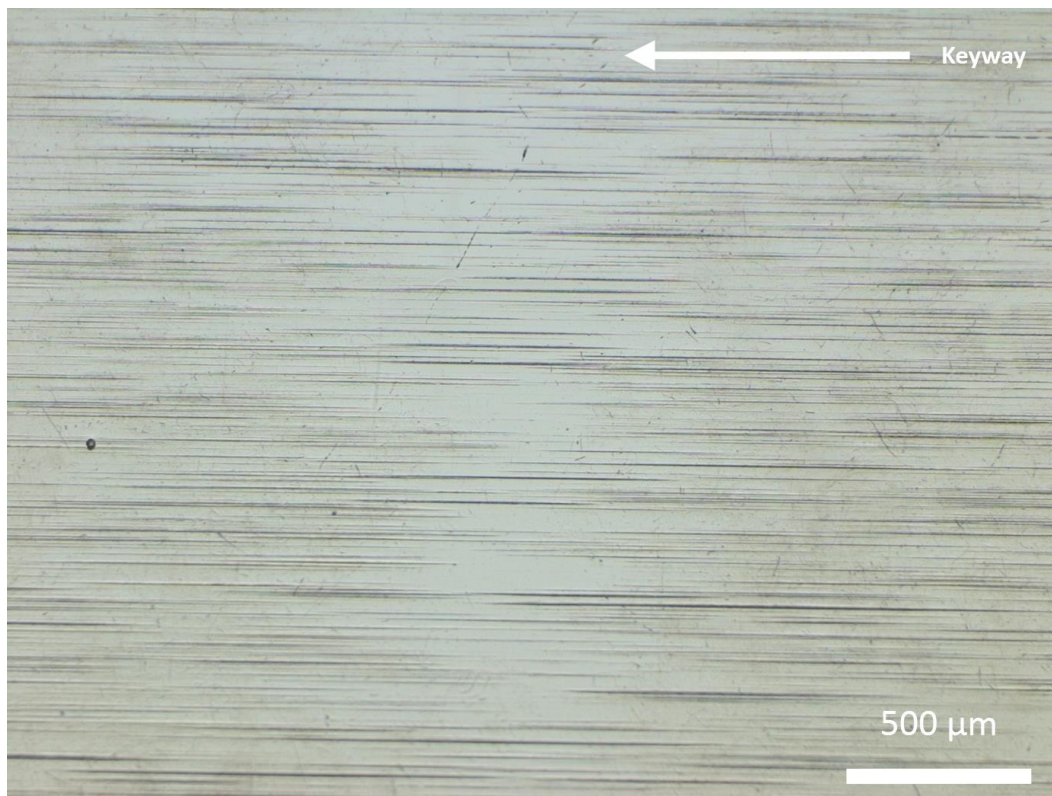
**Figure 20. Bright-field optical micrograph of one of the flat faces of the cam ring from pump 4 (fuel 2, 1200 h).**

Bright-field optical micrographs of the cam ring from pump 5 on the region contacting the bucket surface (Figure 20) showed many horizontal grind marks intact and very little run-in. Pump 5, which was operated with fuel 2, appeared to have less wear than pump 2 (Figure 9), which was operated with fuel 1 for a similar duration.

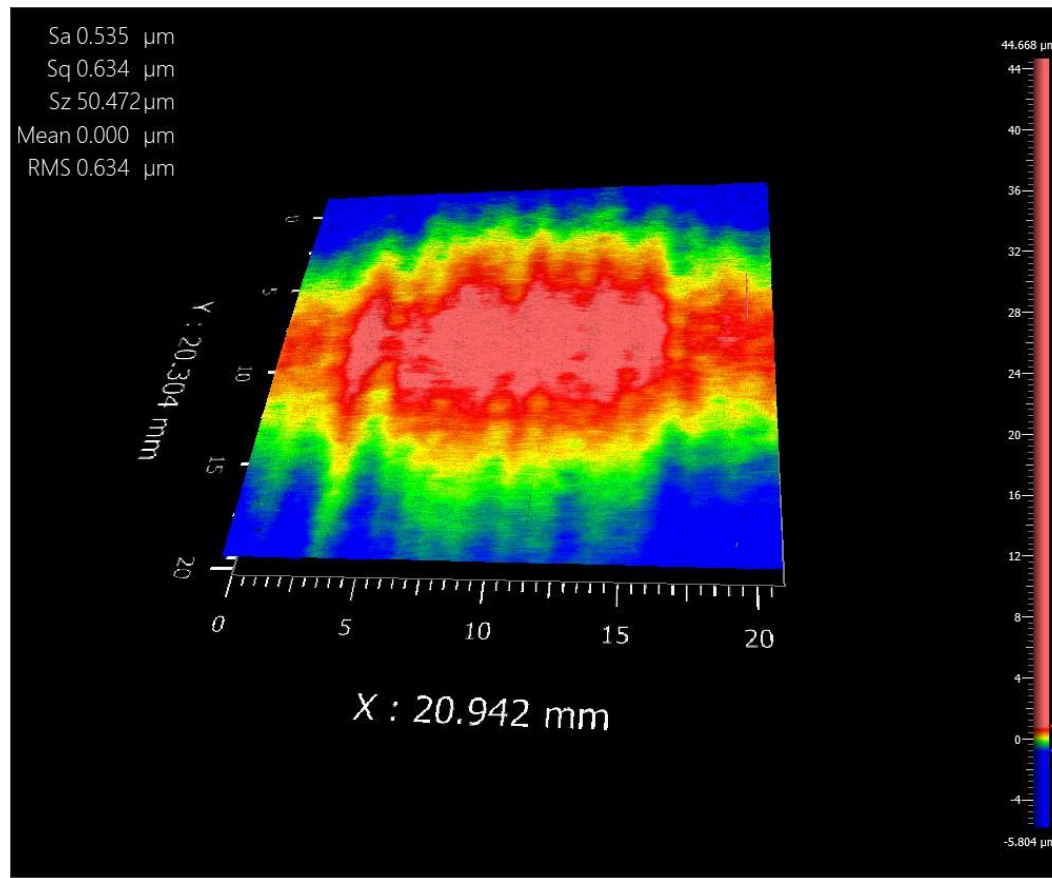
**Figure 21.** Surface profile of one of the flat faces of the cam ring from pump 5 (fuel 2, 1200 h).

The surface profile, shown in Figure 21 of pump 5, confirmed that the wear on the cam ring was low. The cam-ring surfaces retained a similar convex profile to the surface observed in the pristine pump (pump 1). The surface profile the oval-shaped

wear marking was difficult to discern visually. The roughness of the cam-ring surface was  $Sa = 61 \pm 8$  nm. The pump 5 cam ring appeared to be the least run-in and thus was closest to the original roughness.

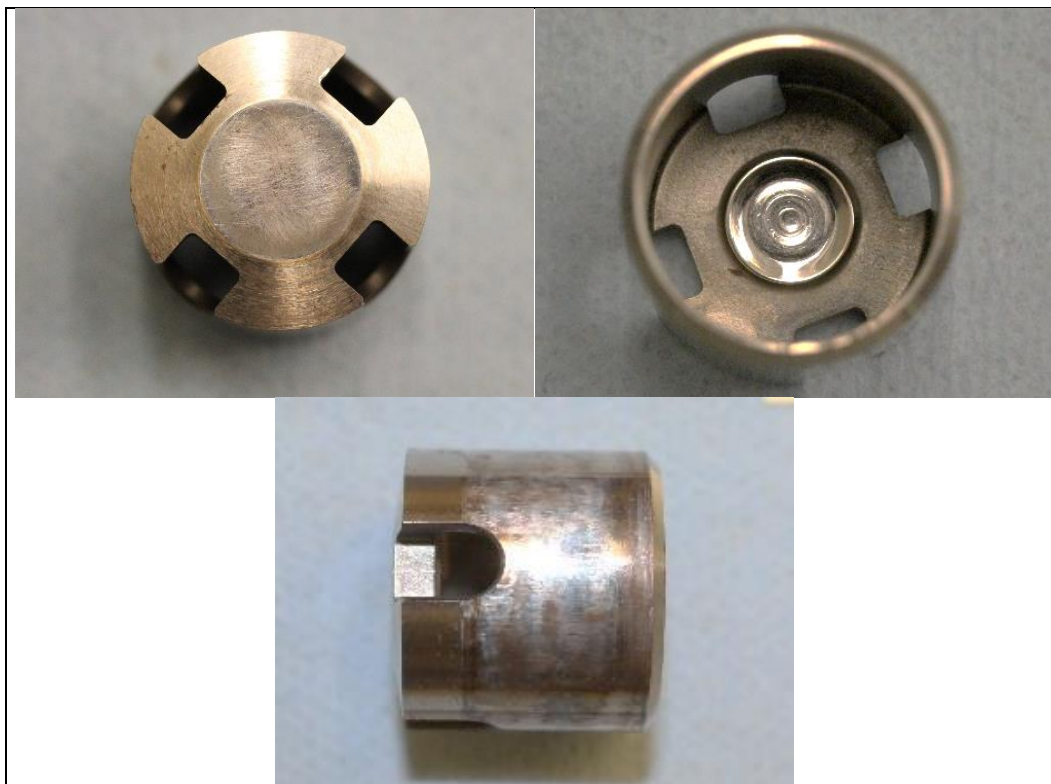
**Figure 27. Bucket from pump 2 (fuel 1, 1052 h).**

Wear was observed on the two exterior faces of the bucket and on the raised platform on the inside of the bucket (Figure 27). The exterior flat surface of the bucket had minimal wear as indicated by the presence of the original brushed finish in the center; however, there were some abrasive scratches observed towards the outer edges (Figure 27, upper left). On the inner surface, there was significant wear of the raise platform resulting in a change in the profile clearly visible by eye (Figure 27, lower center). The wear marks on the inner surface platform appeared to be oriented circumferentially, and the surface appeared more polished than that of pump 1. The wear on the curved surface of the exterior side extended around the entire circumference with a height of approximately 15 mm from the bottom edge (Figure 27, upper right). The wear appeared as discolored areas that had a shiny polished appearance, which indicated that the wear on this surface is most likely due to run-in.

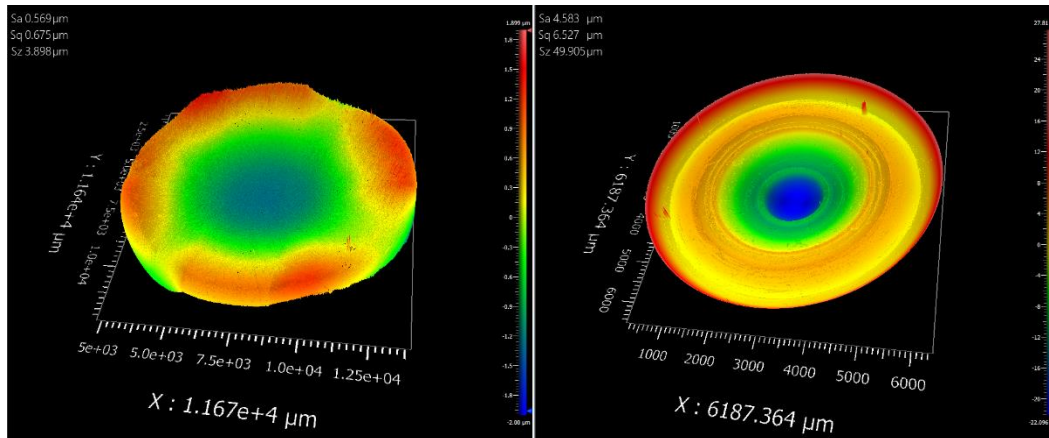
**Figure 29. Surface profile of bucket from pump 2 (fuel 1, 1052 h). Left, exterior flat surface; right, interior raised surface.**

The surface profile of the exterior flat surface of pump 2 had minimal differences when compared with the profile of the pristine pump (Figure 29), except for some roughening of the surface. The height varied over a 2.0- $\mu\text{m}$  range and mostly kept to the concave profile. The roughness of the exterior flat surface was  $S_a = 23 \pm 7 \text{ nm}$ . The surface profile of the interior raised surface was significantly altered by wear (Figure 29). The surface resembled a surface of revolution and there were many visible circumferential abrasive wear marks. The circumferential wear indicates the wear was likely due to rotation of the bucket relative to the plunger. The roughness of the interior raised surface was  $S_a = 105 \pm 48 \text{ nm}$ .

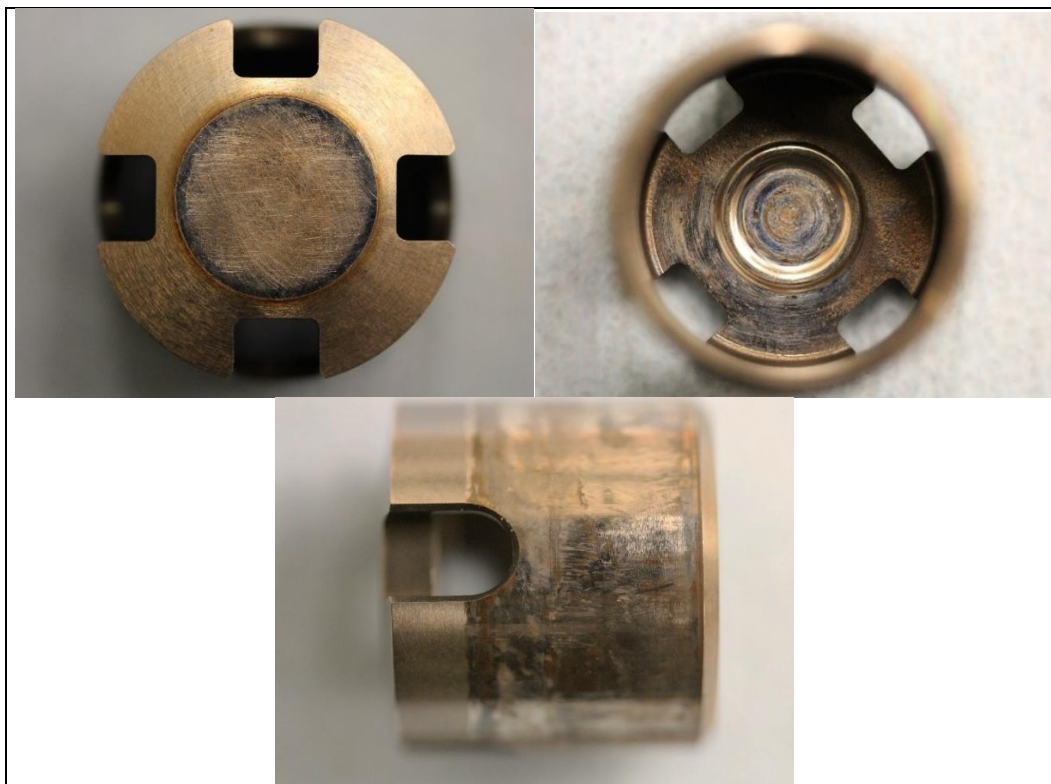
**Figure 30. Bucket from pump 3 (fuel 1, 1800 h).**

The bucket from pump 3 appeared to have wear similar to that of pump 2 (Figure 30). The exterior flat surface of the bucket was darker in color towards the edges (Figure 30, upper left). The number of scratches towards the center of the exterior flat surface appears to be greater in number than in the pristine pump. However, since the curvature was similar to the brushed finish observed in pump 1, it is likely that this surface of the bucket did not wear significantly. The raised platform on the inside of the bucket was worn in a similar way to pump 2 (Figure 30, lower center). The exterior curved surface of the bucket of pump 3 had more run-in than pump 2 as indicated by the increased size of the shiny patches (Figure 30, upper right). Similar to pump 2, this run-in did not appear to be a detriment to normal pump operation.

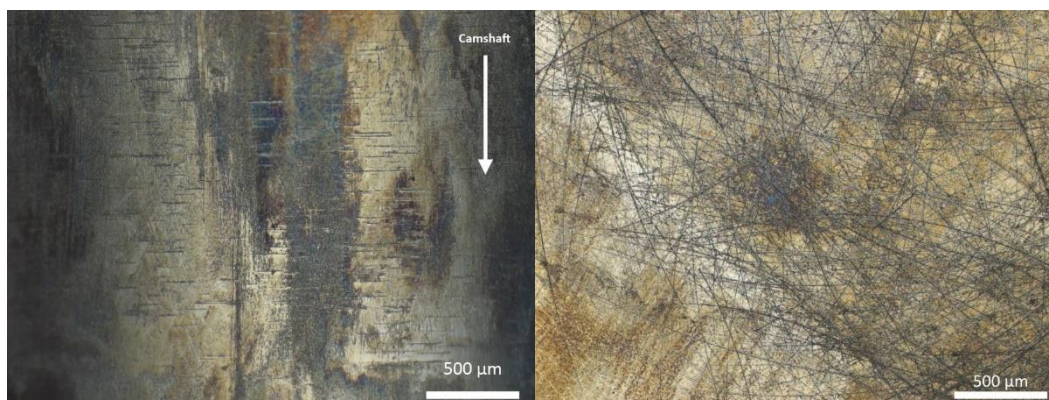
**Figure 31. Bright-field optical micrographs of bucket from pump 3 (fuel 1, 1800 h). Left, exterior curved surface; right, exterior flat surface.**

Bright-field micrographs of the bucket for pump 3 (Figure 31) showed many similarities to pump 2. The exterior curved surface (Figure 31, left) appeared to be smoother than in the pristine pump and had the same type of discoloration observed in pump 2. Pump 3 differed from pump 2 in that some of the circumferential grind marks present in the pristine surface were still visible for pump 3, suggesting that the surface had not worn as much as in pump 2, despite its longer run time. Such behavior is not unusual since the run-in process is usually dominated by conditions in the early stages of contact and does not alter the surface as significantly in the later stages. The exterior flat surface of the pump 3 bucket (Figure 31, right) had more brown discoloration than pump 2. In addition, the surface was worn slightly in certain spots, such as is seen in the bottom-left corner of the image of the exterior flat surface (Figure 31, right) where the isotropic grind marks were absent and several diagonal marks were present, all with the same direction. These marks suggest that mild abrasion of the surface took place.

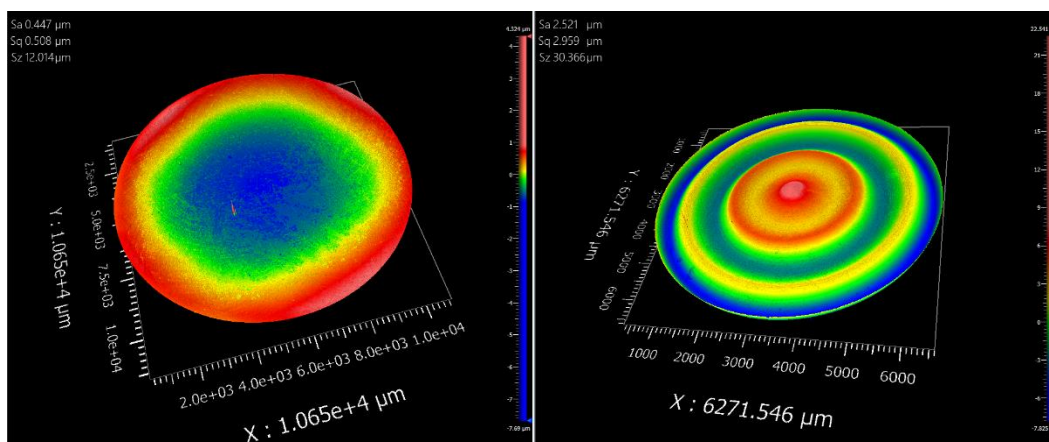
**Figure 32. Surface profile of bucket from pump 3 (fuel 1, 1800 h). Left, exterior flat surface; right, interior raised surface.**

The surface profile of the pump 3 bucket (Figure 32) was similar to the profile for pump 2. The exterior flat surface had the same concave profile (Figure 32, left). The roughness of the exterior flat surface was  $Sa = 41 \pm 17$  nm. The wear observed on the surface did not significantly alter the form of the surface. The profile for the interior raised surface in pump 3 (Figure 32, right) was similar to the profile in pump 2 in that both surfaces had circumferential wear marks that made the surfaces resemble bodies of rotation. However, the low point in the profile was in the center for pump 2, whereas the high point was in the center for pump 3. Therefore, the wear was not preferential to any specific portion of the surface between the two pumps. The roughness of the interior raise surface was  $Sa = 423 \pm 196$  nm.

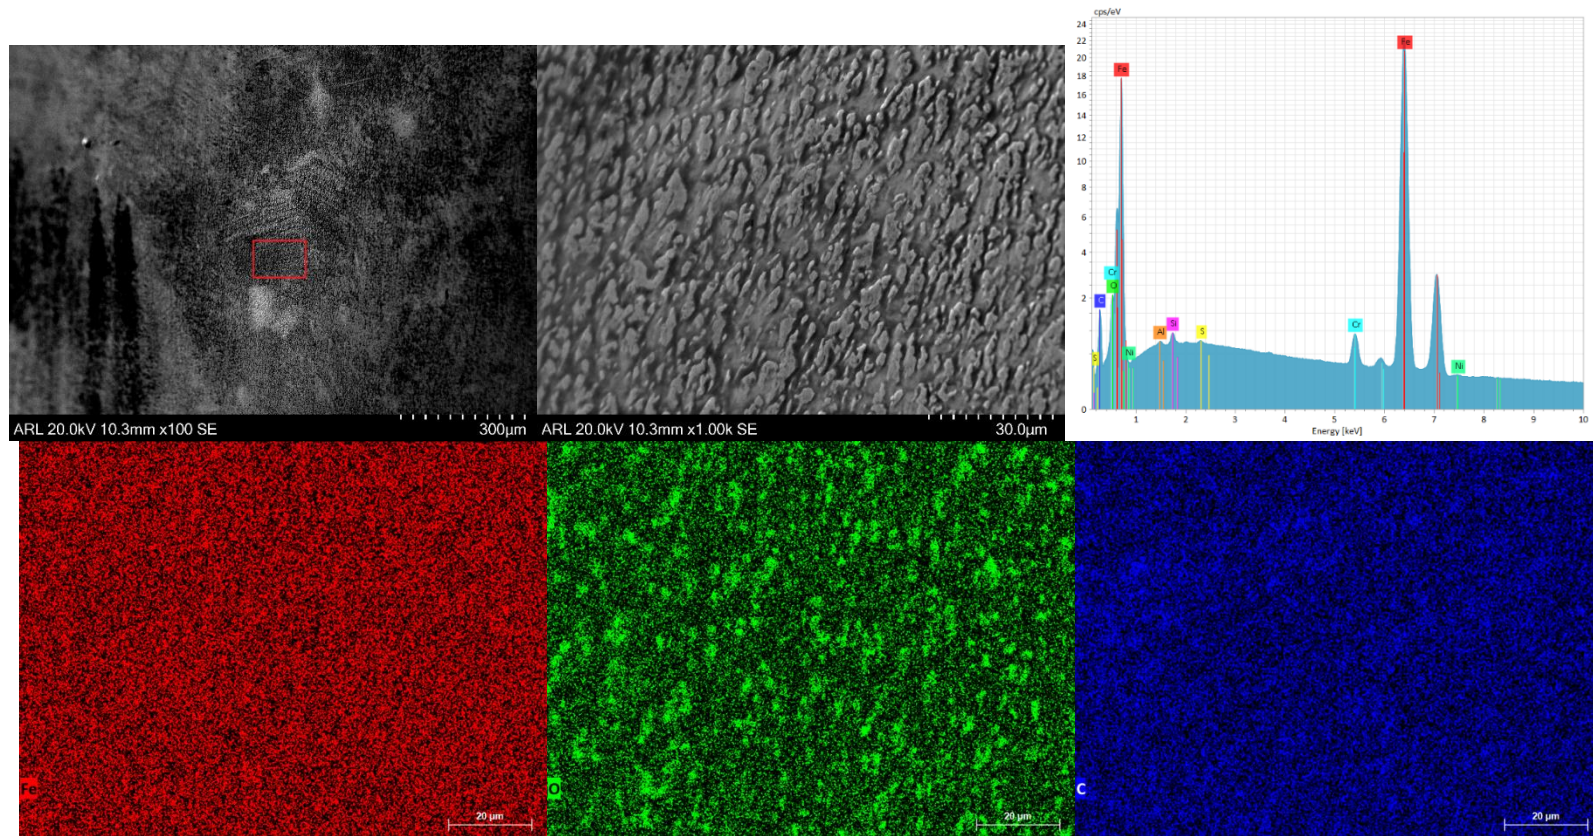
The discolored region of the exterior curved surface of the pump 3 bucket was observed more closely with SEM (Figure 33). The surface was full of many small islands approximately 2 to 10  $\mu\text{m}$  wide with flat tops. The islands may have formed due to the growth of solid deposit at several nucleation sites on the steel, while the flat tops were formed by wear of the top of the structure during sliding. The EDS

Figure 33. SEM micrograph taken with SE detector at 100× (top left) and 1000× magnification (top center), EDS spectra (top right), and EDS elemental maps at 1000× magnification of iron (bottom left), oxygen (bottom center), and carbon (bottom right) of the exterior curved surface on the bucket of pump 3 (fuel 3, 1800 h).

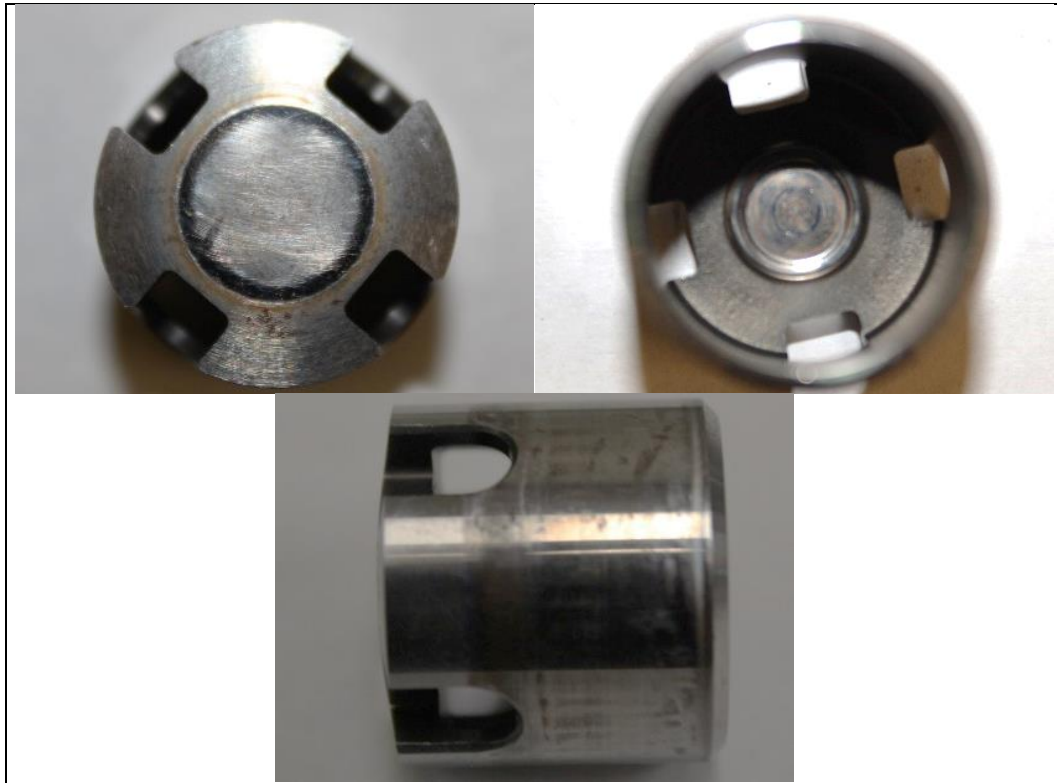
**Figure 34. Bucket from pump 4 (fuel 2, 476 h).**

The pump 4 bucket is shown in Figure 34. Some discoloration was observed on the exterior curved surface and the ring outside of the exterior flat surface, but there was significantly less discoloration overall for pump 4 than for pumps 2 and 3. Some scratches were seen on the exterior curved surface as well as a few marks on the exterior flat surface.

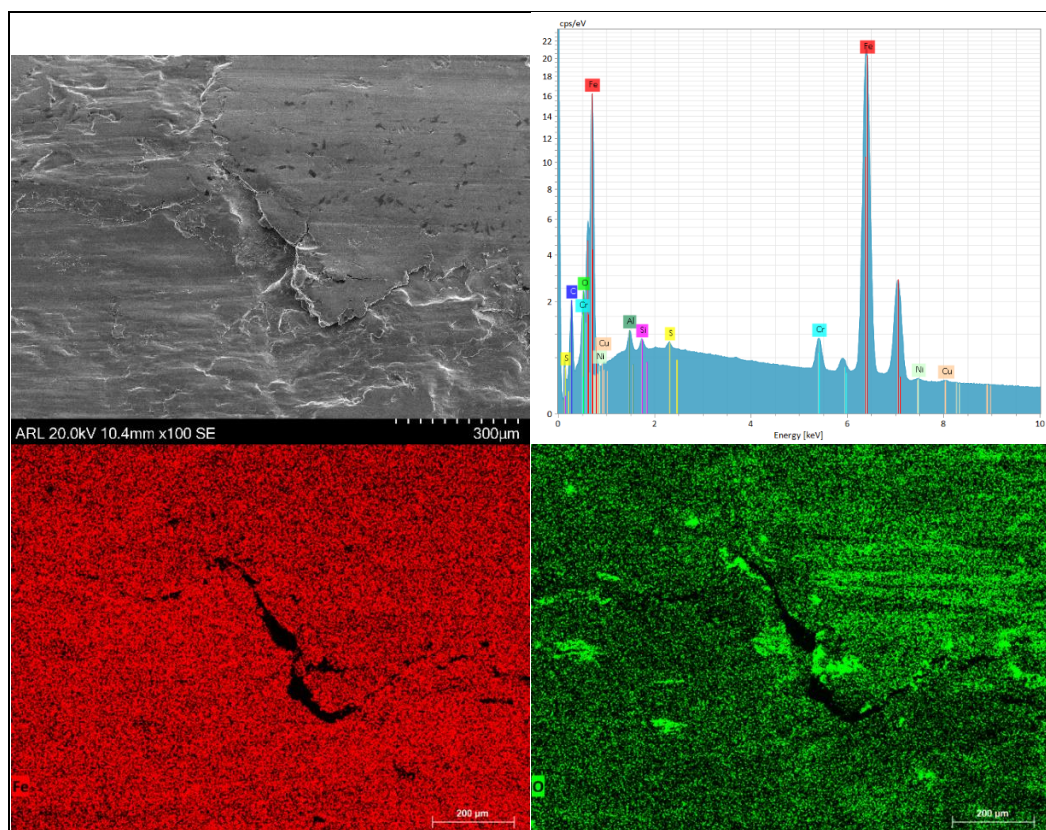
**Figure 58. SEM micrograph taken with SE detector (top left), EDS spectra (top right), and EDS elemental maps of iron (bottom left), oxygen (bottom right) of scuffing on the plunger shaft from pump 5 (fuel 2, 1200 h).**

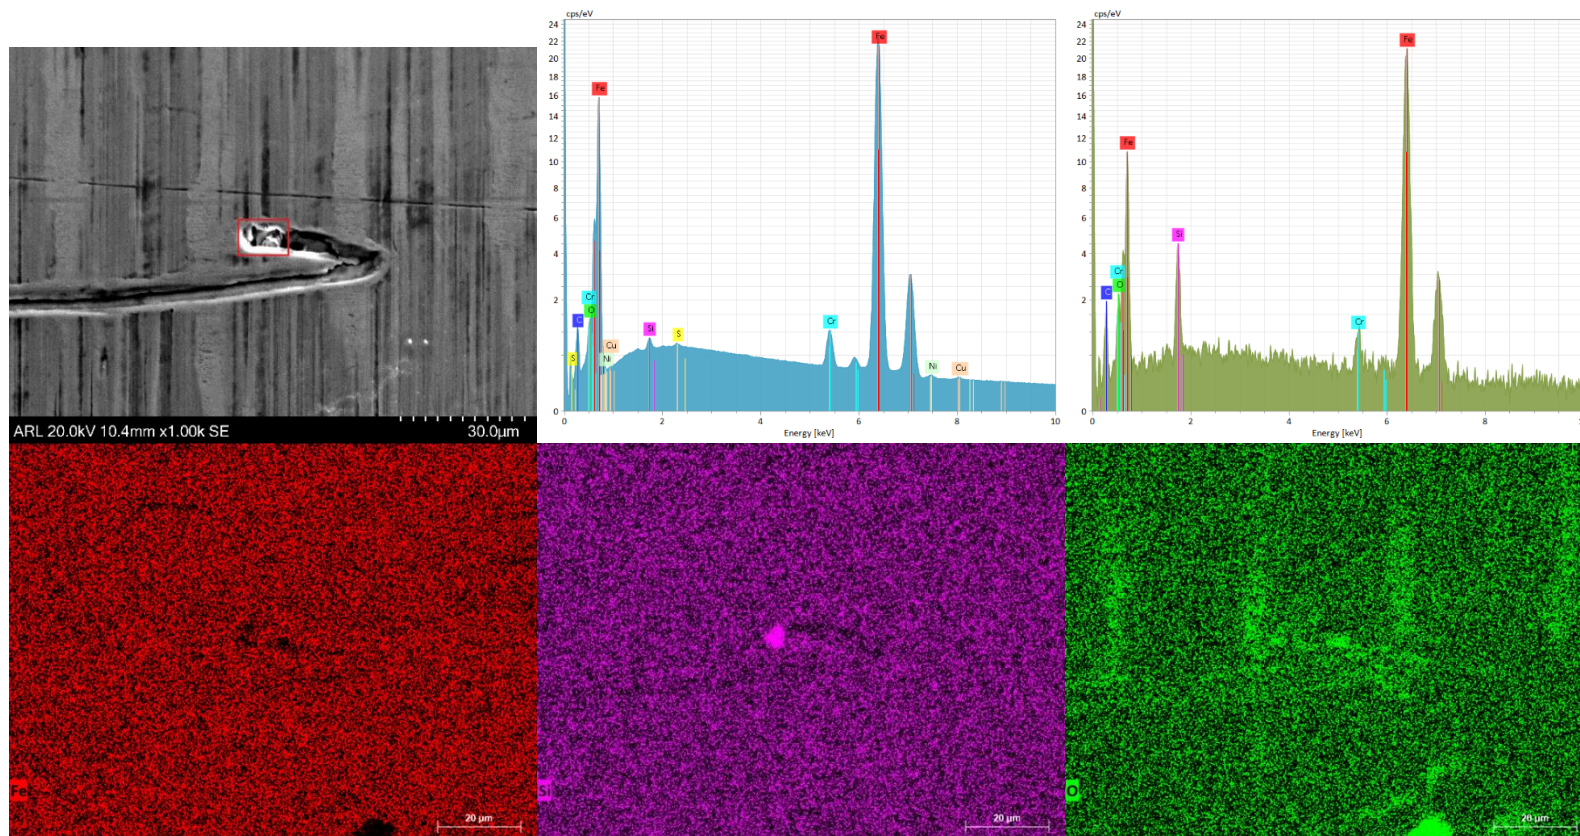
Figure 59. SEM micrograph taken with SE detector (top left), EDS spectra of the full area (top center), boxed particle (top right), and EDS elemental maps of iron (bottom left), silicon (bottom center) and oxygen (bottom right) of a particle on the plunger shaft from pump 5 (fuel 2, 1200 h).
