ARL-TR-10379 • JULY 2026

# Laying the Foundation for Project Interception: Experiments, Modeling, and Overhauls for Rotorcraft Transmissions for AI/ML Prognostics

by Mark Riggs, Adrian Hood, Ryan Emerson, and  
Marc Gonzalez

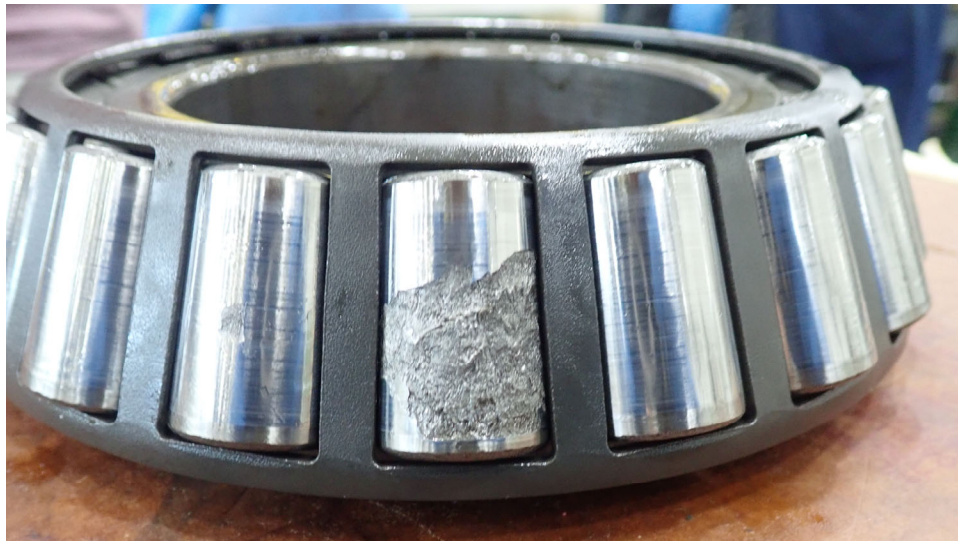
**Figure 10. PI3 bearing damage found during overhaul.**

The overhaul photographs agreed with the chip analysis with heavy damage to a tapered roller bearing (shown in Figure 10). These pictures and additional images taken during the overhaul would be used to characterize the bearing fault in a dynamic model if PI gains funding for continued work. The experimental data associated with PI3 would then be compared with the model data for validation.
