ARL-TR-10065 • MAR 2025

# Failure Analysis of High-Pressure Fuel Pumps Operated with Two Jet Fuels

by Nikhil Murthy, Caleb Matzke, Caleb McCoy, and Stephen Berkebile

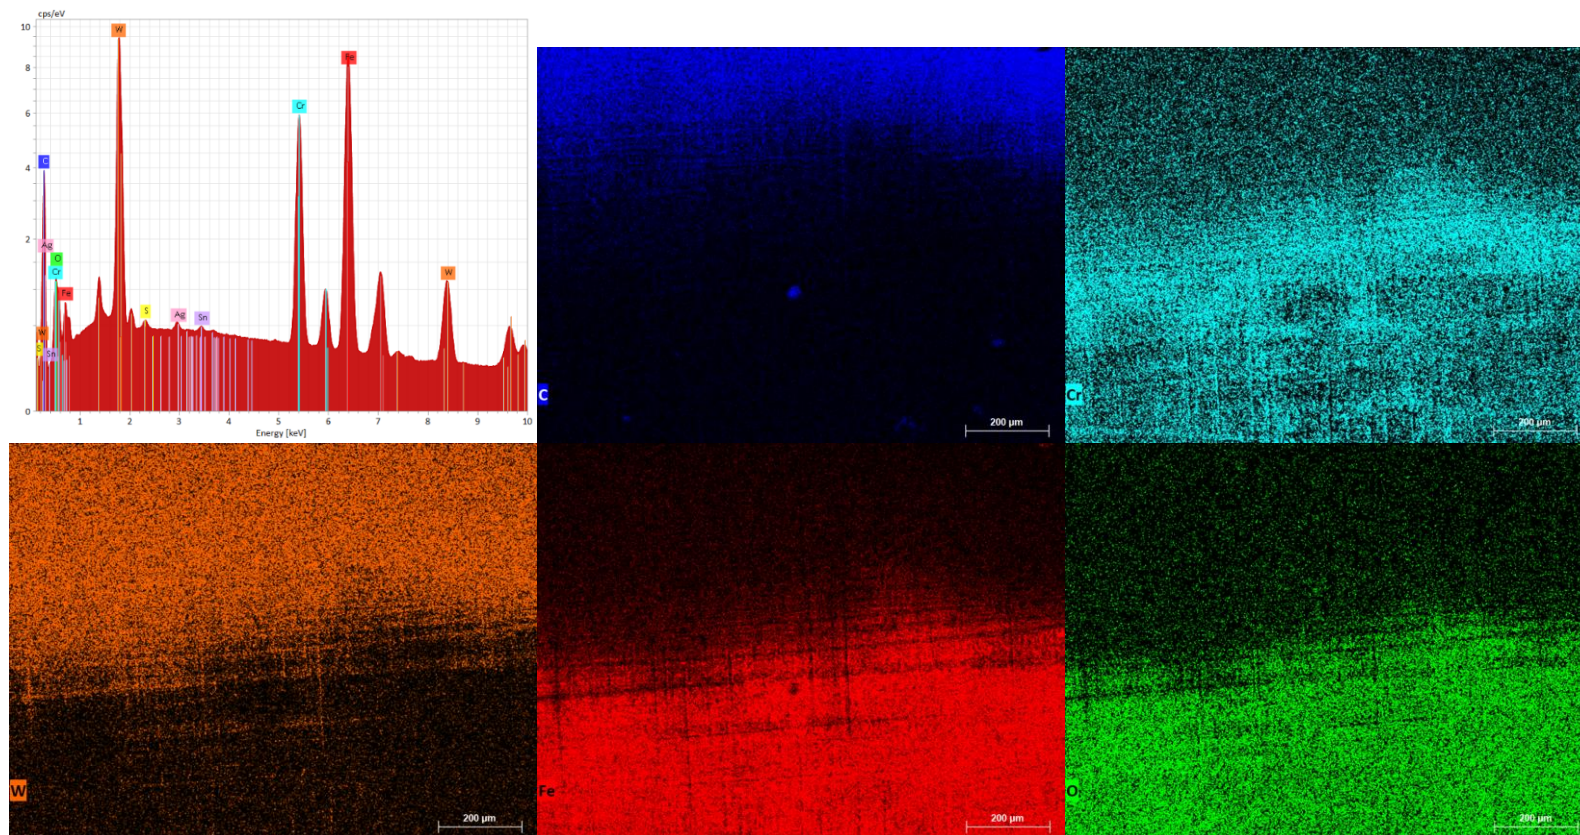
may be an impurity or dopant present in the carbon layer. By combining this information with the previous Raman spectra (Figure 6), it can be concluded that the material on the cam ring is likely a diamond-like carbon coating containing tungsten on a chromium bond layer with possible tungsten content on a low-alloy chrome–steel substrate.

Figure 15. EDS elemental spectra (top left) and EDS elemental maps of carbon (top center), chromium (top right), tungsten (bottom left), iron (bottom center), and oxygen (bottom right) of the cam ring from pump 3 (fuel 1, 1800 h).

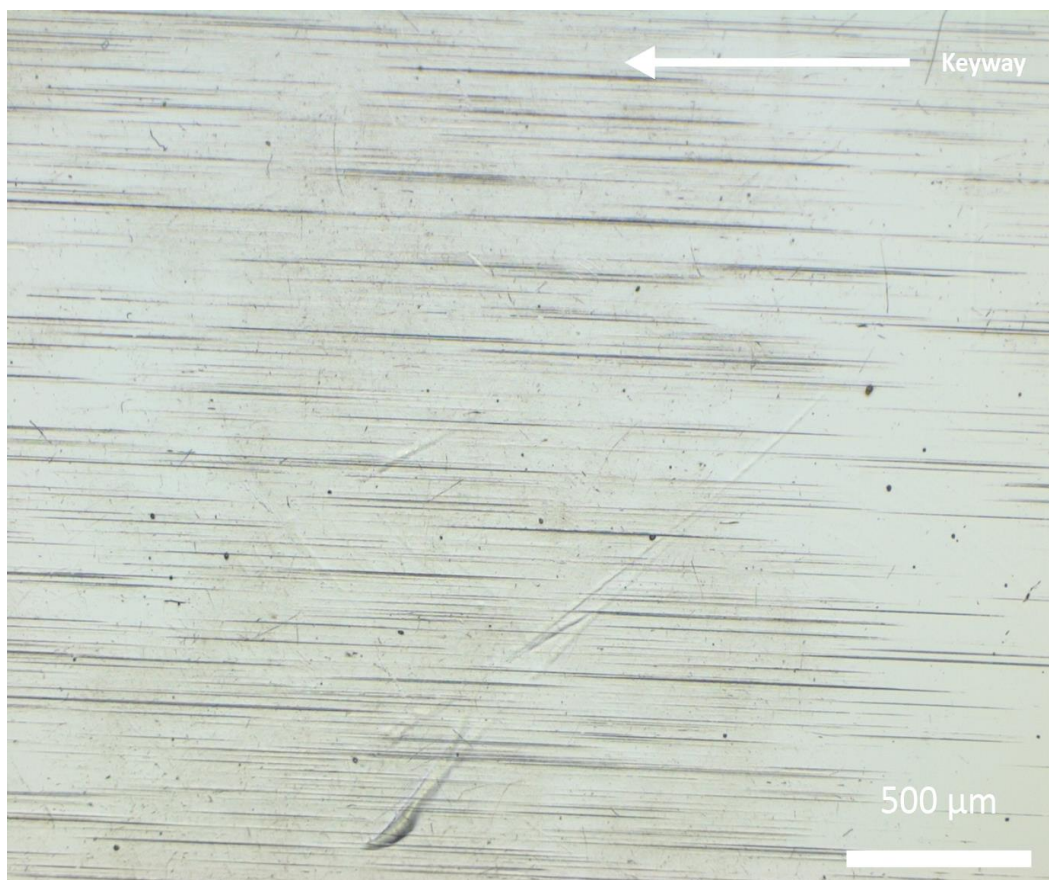
**Figure 17. Bright-field optical micrograph of one of the flat faces of the cam ring from pump 4 (fuel 2, 476 h).**

The surface of the pump 4 cam ring within the region contacting the bucket is shown in more detail in Figure 17. The surface had a run-in appearance similar to pump 2 (Figure 8), but with more horizontal grind marks visible.

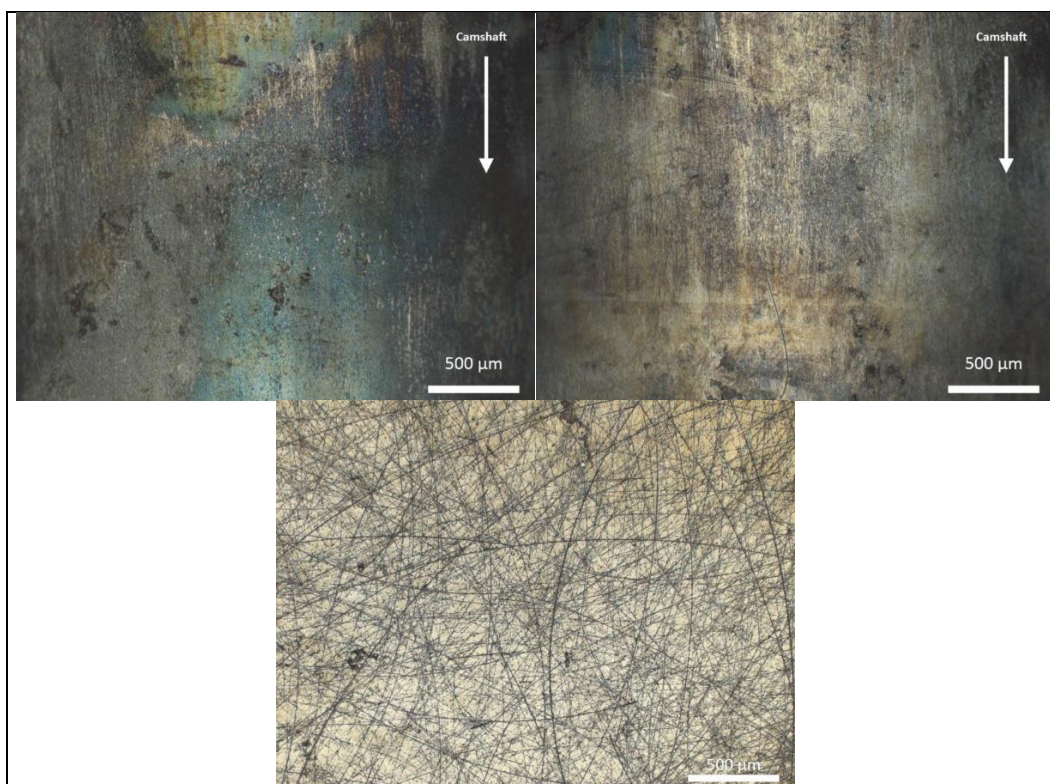
**Figure 28. Bright-field optical micrographs of bucket from pump 2 (fuel 1, 1052 h). Left, exterior curved surface; center, exterior curved surface; right, exterior flat surface.**

Observation of additional details of the surfaces in the bright-field micrographs (Figure 28) revealed that two differences could be drawn between pumps 1 and 2 on the exterior curved surface. The first was that the surface of pump 2 appeared to have a much smoother appearance. The circumferential grind from the pristine bucket was absent from the pump 2 bucket. Instead, finer axial scratches were visible. The second difference was a color change. Patches of blue, brown, and dark matte grey were visible in pump 2 as opposed to the bright silvery grey in the pristine pump 1. The coloration of the surface was similar to tempered steel, which changes color due to thin film interference within a thin surface oxide film. This suggests that the surface may have tempered or formed a similar thin film from surface chemical interactions with the fuel. The micrograph of the exterior flat surface of the pump 2 bucket showed little difference from pump 1 except for the presence of dark-brown patches.

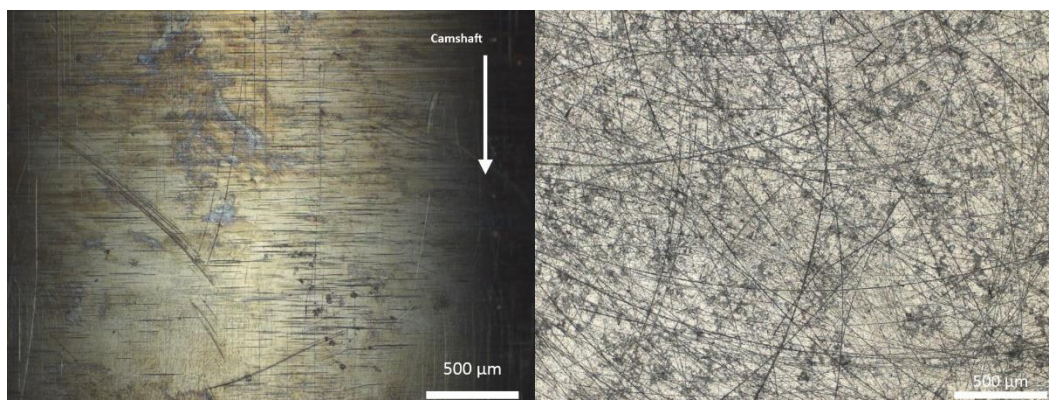
**Figure 35. Bright-field optical micrographs of bucket from pump 4 (fuel 2, 476 h). Left, exterior curved surface; right, exterior flat surface.**

Optical micrographs of the exterior curved surface show these features more closely (Figure 35). A slight discoloration was seen on the exterior curved surface (Figure 35, left). Additionally, there were several scratches on the plunger oriented along the axis of the pump bore. These scratches were likely abrasive wear marks from the bucket sliding against the pump bore. The exterior flat surface had many randomly oriented scratches, which appear similar to the original isotropic grind (Figure 35, right).

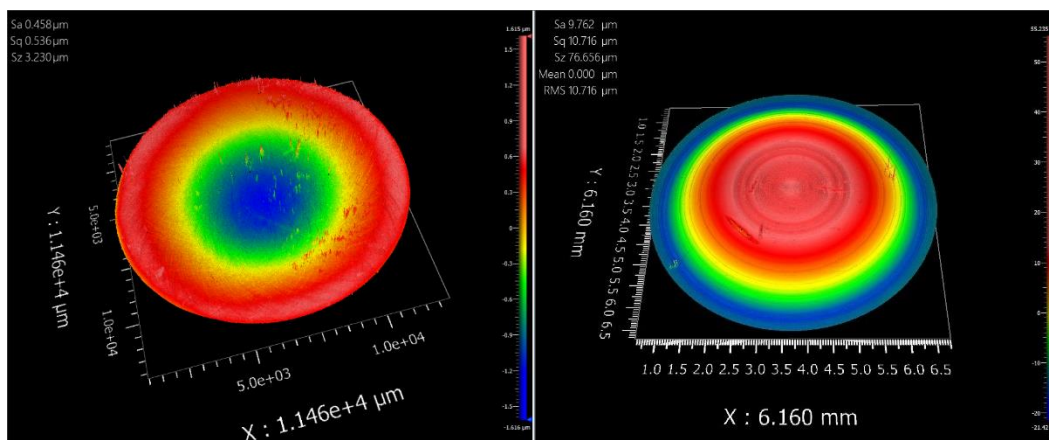
**Figure 36. Surface profile of bucket from pump 4 (fuel 2, 476 h). Left, exterior flat surface; right, interior raised surface.**

The surface profile of the pump 3 bucket is shown in Figure 36 and had a similar appearance to the other pumps. The exterior flat surfaces had the same concave profile (Figure 36, left). The roughness of the exterior flat surface was  $S_a = 41 \pm 7$  nm. The wear observed on the surface did not significantly alter the form of the surface. The profile for the interior raised surface had a prominent convex curvature with a few radial scratches (Figure 36, right). Similar to pumps 2 and 3, the pump 4 surface resembles a surface of revolution. However, the circumferential grooves due to wear were located at a different radius, as with the other pumps. The roughness of the interior raise surface was  $S_a = 249 \pm 82$  nm.

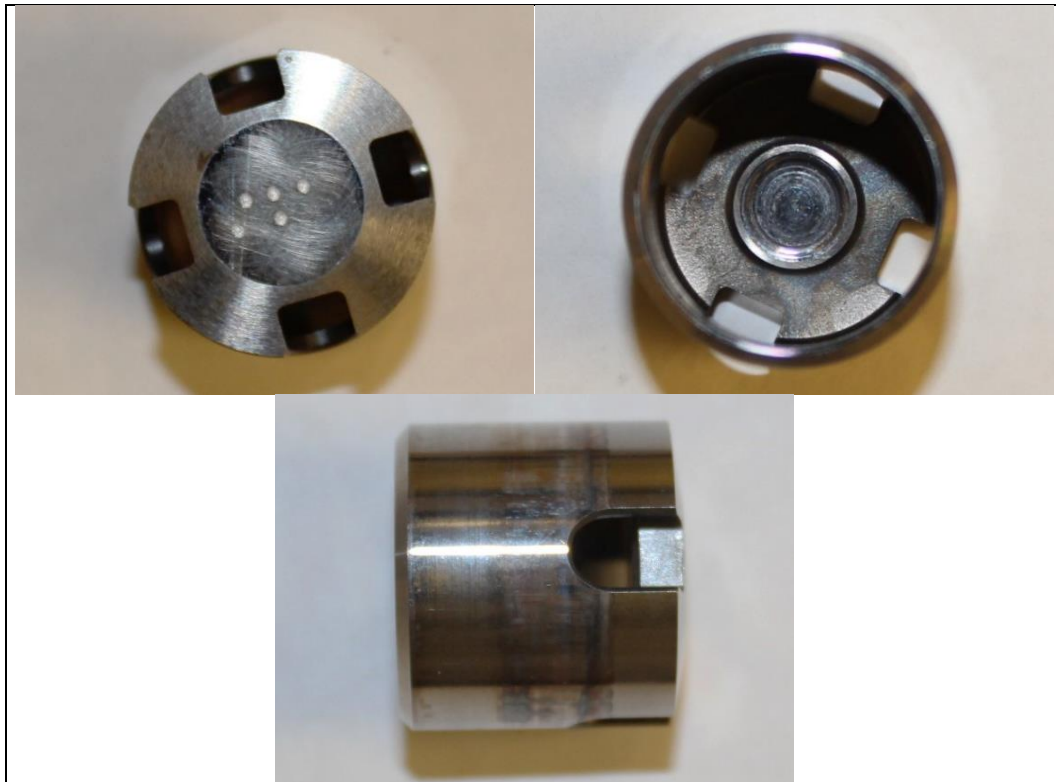
**Figure 37. Bucket from pump 5 (fuel 2, 1200 h).**

The bucket from pump 5 had a shiny metallic appearance (Figure 37) similar to the pristine pump. The exterior flat surface had several abrasive scratches running unidirectionally (Figure 37, upper left) as opposed to the isotropic grind in the pristine pump. The five divots visible on the flat surface were due to hardness measurements conducted after operation of the pump. The interior raised surface had some circumferentially oriented scratches (Figure 37, center). The exterior curved surface of the bucket had a ring towards the inward facing edge which appeared less worn than the surrounding surface (Figure 37, upper right). This portion of the pump does not contact the housing during operation of the pump. At the boundary between this portion of the surface and the contacting surface, there appeared to be slight discoloration, but it was less than the surfaces in pumps 2 and 3.

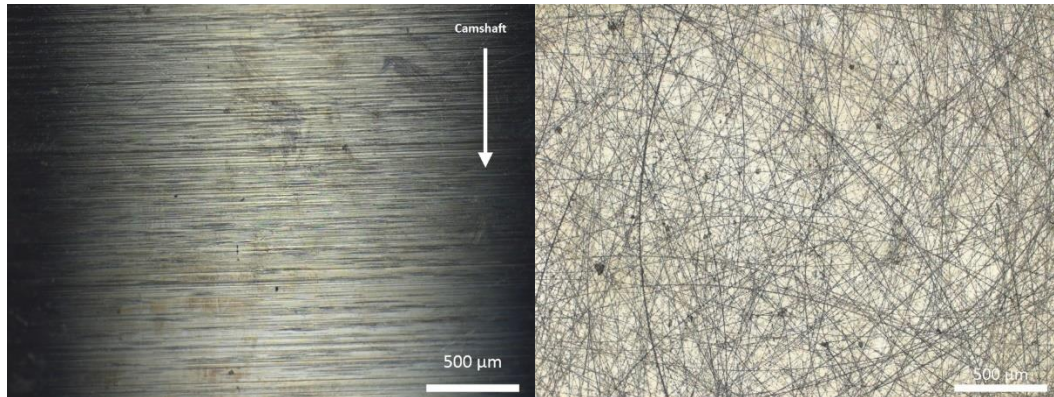
**Figure 38.** Bright-field optical micrographs of bucket from pump 5 (fuel 2, 1200 h). Left, exterior curved surface; right, exterior flat surface.

Bright-field micrographs of the bucket show that the exterior curved surface of the bucket from pump 5 (Figure 38, left) kept many of the same features observed in the pristine pump. The circumferentially oriented grind marks were still visible. There appeared to be a few randomly oriented scratches and some small patches of discoloration, but these compromised a small portion of the surface. The isotropic grind was still visible on the exterior flat surface of the bucket (Figure 38, right).

This suggests that there may have been some abrasive wear on the bucket. These abrasive scratches appeared to be the same size as the original grind.

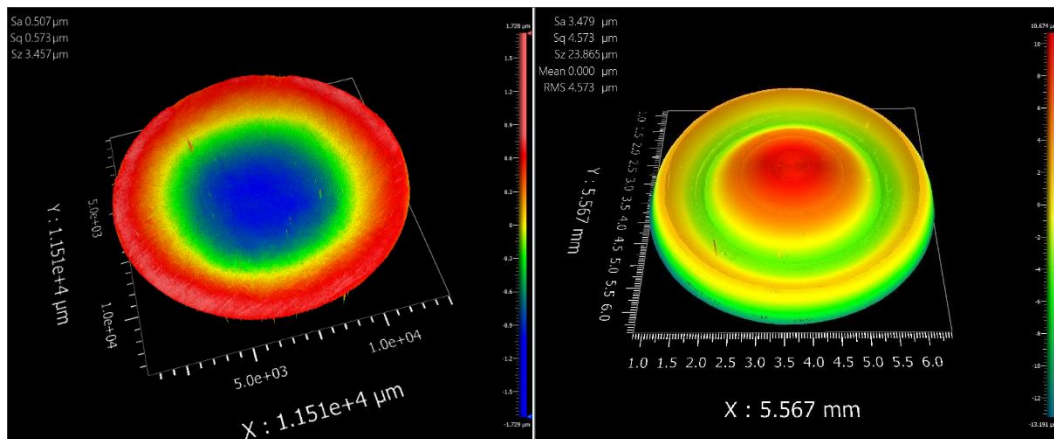
**Figure 39.** Surface profile of bucket from pump 4 (fuel 2, 1200 h). Left, exterior flat surface; right, interior raised surface.

The surface profile of the pump 5 bucket is shown in Figure 39. The exterior flat surfaces had the same concave profile (Figure 39, left). The roughness of the exterior flat surface was  $S_a = 38 \pm 12$  nm. There was not a significant difference to the other pumps in the form of the surface. The profile for the interior raised surface also resembled a surface of revolution (Figure 39, right) with a unique circumferential radial wear pattern as the other pumps. The roughness of the interior raise surface was  $S_a = 581 \pm 302$  nm.

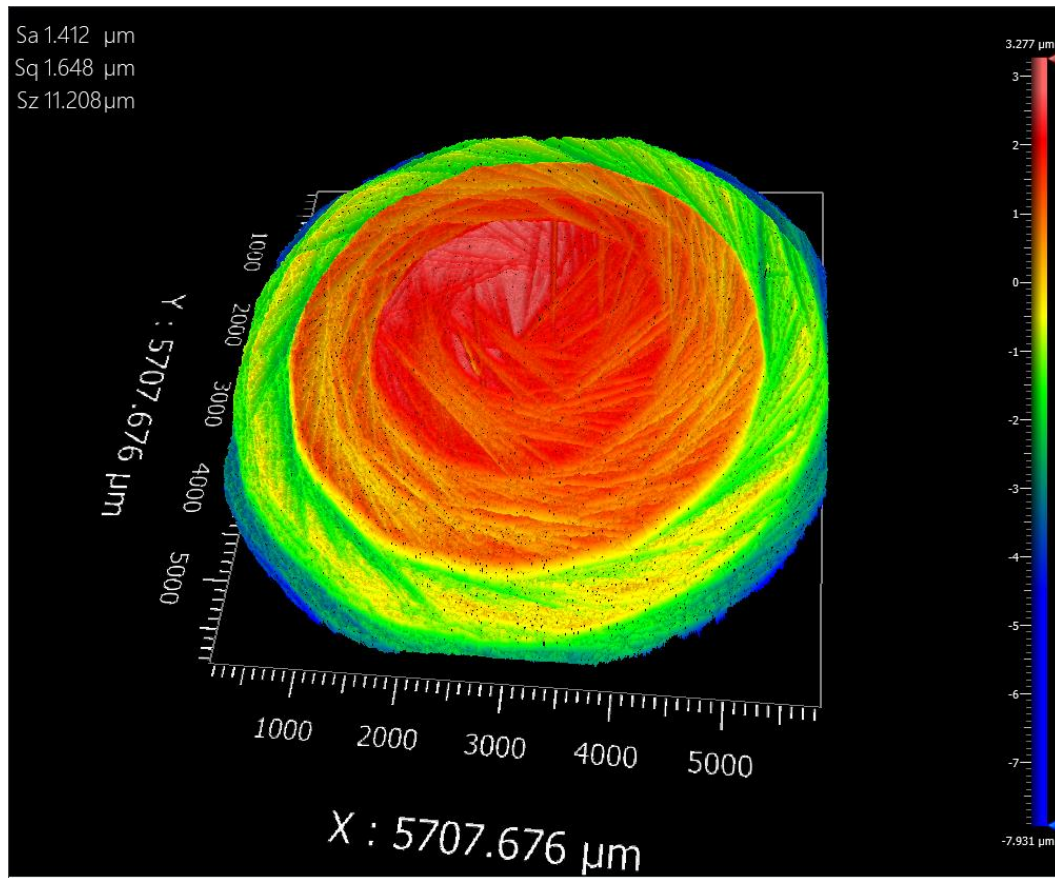
**Figure 42. Surface profile of plunger base from pump 1 (pristine, 0 h).**

A close-up surface profile of a portion of the plunger base reveals the cross-hatched scratches from the brushed finish (Figure 42). The raised portion of the base of the plunger had a convex profile with a height variation of approximately 7  $\mu\text{m}$  over a width of 5.7 mm. The roughness of the plunger base was  $S_a = 358 \pm 148 \text{ nm}$ . The roughness of the plunger shaft was  $S_a = 46 \pm 8 \text{ nm}$ .

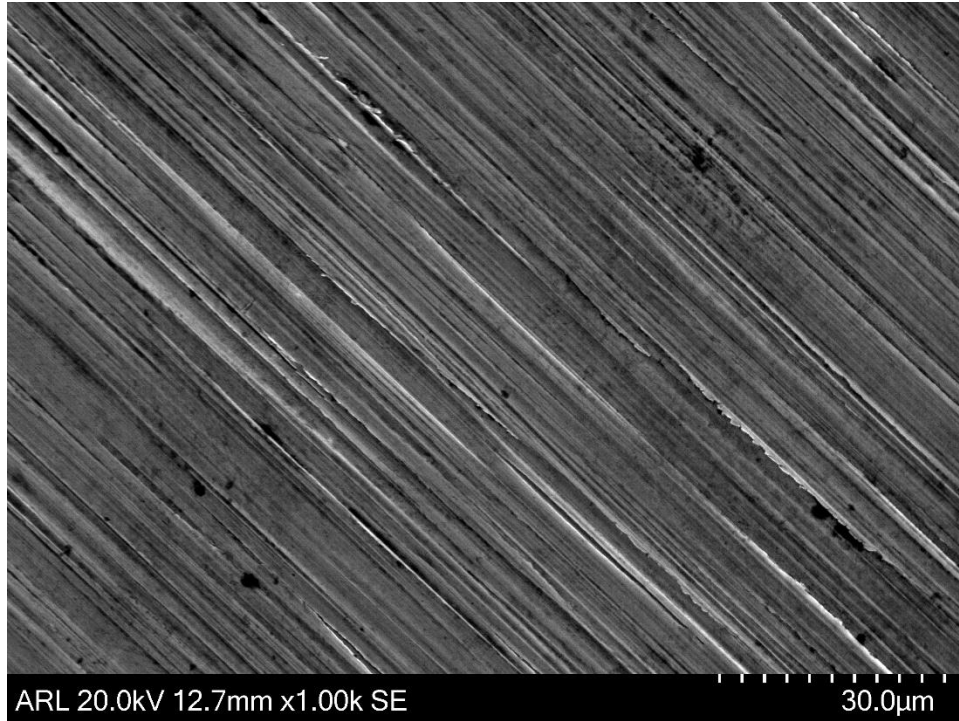
**Figure 43. SEM micrograph taken with SE detector of the plunger shaft from pump 1 (pristine, 0 h).**

The SEM micrograph in Figure 43 shows the circumferentially oriented grind of the plunger shaft going from the top left to the bottom right of the micrograph. The grind marks were approximately 2 to 5  $\mu\text{m}$  wide.

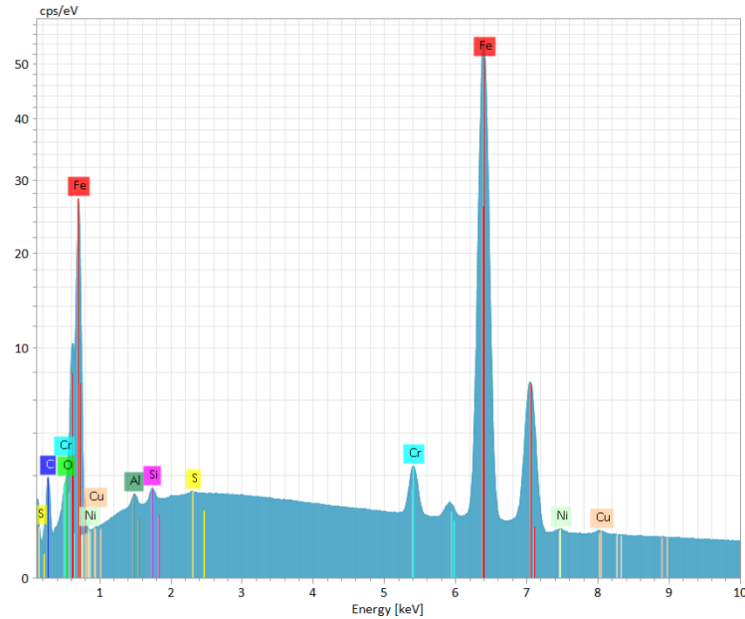
**Figure 44. EDS spectra of the plunger shaft from pump 1 (pristine, 0 h).**

The elemental composition of the plunger can be seen from the EDS spectra in Figure 44. The spectra shows that plunger was predominantly iron with small quantities of chromium, nickel, copper, aluminum, and silicon. The aluminum and silicon signals may have come from the plunger material or from the vacuum chamber and EDS detector, respectively. Thus, the plunger is likely to be a low-alloy chrome steel such as AISI 52100.

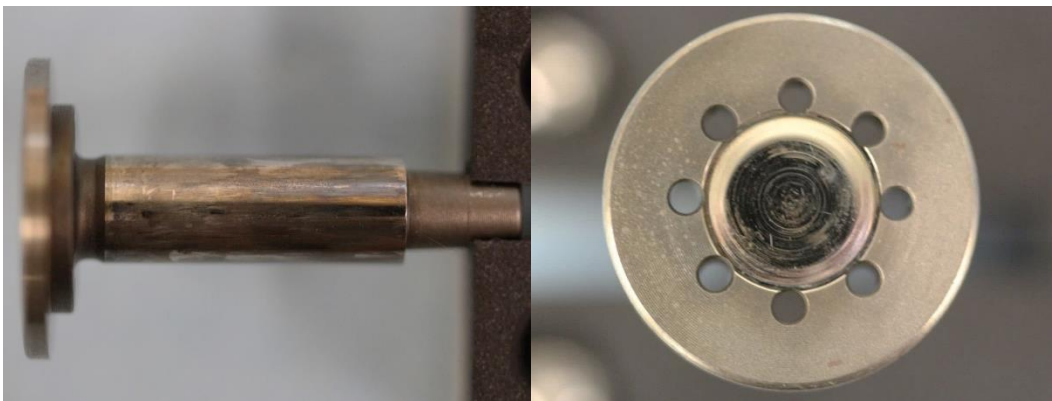
**Figure 45. Plunger from pump 2 (fuel 1, 1052 h).**

Wear was observed along the central shaft and the raised surface on the bottom face of the plungers of pump 2 (Figure 45). The wear on the raised surface was enough to visibly remove the surface finish. The wear marks primarily appear to be oriented axially, and the surface appeared shinier and more polished. The wear on the shaft of the plunger appeared along the entire length and around the entire circumference; however, the overall shape did not appear significantly altered. In addition, the pump 2 plunger had areas colored brown and dark blue as opposed to the silvery metallic color of the pristine plunger. There appeared to be several abrasive marks oriented along the axial direction covering up the original circumferential grind.

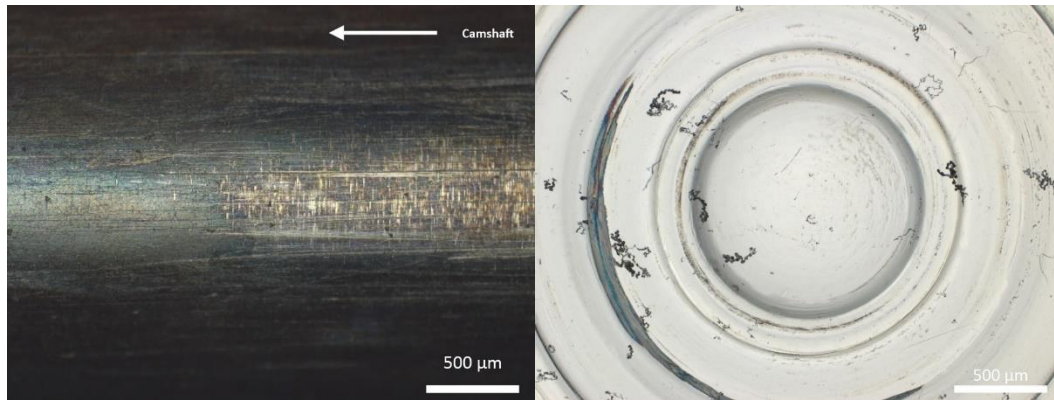
**Figure 46.** Bright-field optical micrographs of plunger from pump 2 (fuel 1, 1052 h). Left, shaft; right, base.

Bright-field micrographs of the cylindrical portion of the plunger show the discoloration and wear in more detail (Figure 46, left). The discoloration in the plunger was similar to that of the bucket, where it was suspected that the coloring was caused by thin film interference from tempering of the steel or film formation from surface chemical interactions with the fuel. Figure 46 also shows how the surface texture had been altered. Only small portions of the original circumferential grind were visible. The deepest portions of these grind marks appeared to be the only areas where the metallic color of the pristine plungers was still visible. Much of the other area appeared to be smoothed out; however, there were also many primarily axially oriented scratches. This was likely caused by abrasive third-body wear, either from particulates in the fuel or wear debris from other portions of the pump. In pump 5 below, fine silica particles were observed to be embedded at the end of similar scratches in the plunger. The plunger base was much smoother in appearance with some grooves in the shape of concentric circles (Figure 46, right).

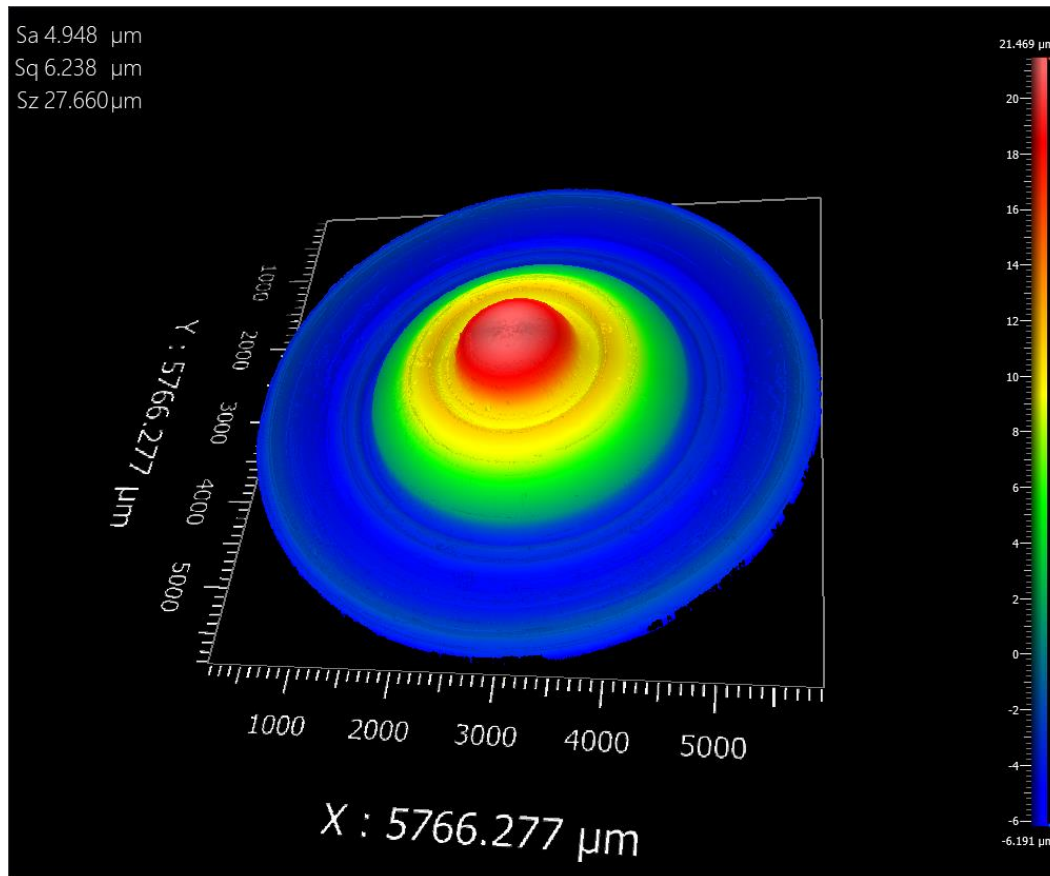
**Figure 47. Surface profile of plunger base from pump 2 (fuel 1, 1052 h).**

The profile of the base of the plunger (Figure 47) revealed a wear pattern with circumferentially oriented abrasive wear marks, which made the surface resemble a surface of revolution. When compared with the profile of the interior raised surface of the pump 2 bucket, the plunger surface appeared to be the inverse pattern, having high points corresponding to low areas on the bucket. These two surfaces must be rotating relative to each other during operation, causing this circular wear pattern. The surfaces conform to each other to minimize local stresses between the mating surfaces. The roughness of the plunger base was  $S_a = 146 \pm 190$  nm. The roughness of the plunger shaft was  $S_a = 82 \pm 16$  nm. The used plunger shaft was rougher than the pristine plunger due to the presence of the axially aligned abrasive marks.

The hardness of the plunger was  $60.2 \pm 1.4$  HRC.

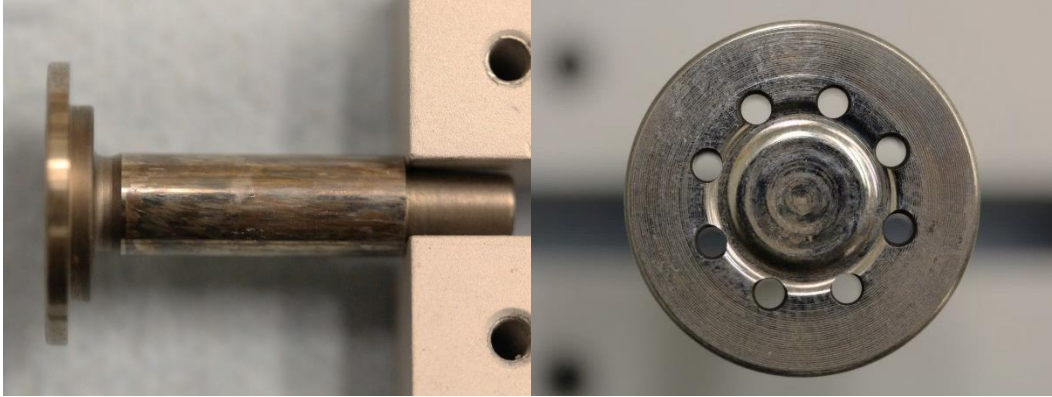
**Figure 48. Plunger from pump 3 (fuel 1, 1800 h).**

The plungers from pump 3 had several dark markings and several axially oriented scratches (Figure 48). This appearance was similar to the plunger of pump 2 and matched the discoloration seen in the pump 3 bucket. Lastly, the plunger contained wear on the outer portion of the raised platform at the base where the plunger contacts the bucket. The wear on the plungers appeared to match the wear on the buckets.

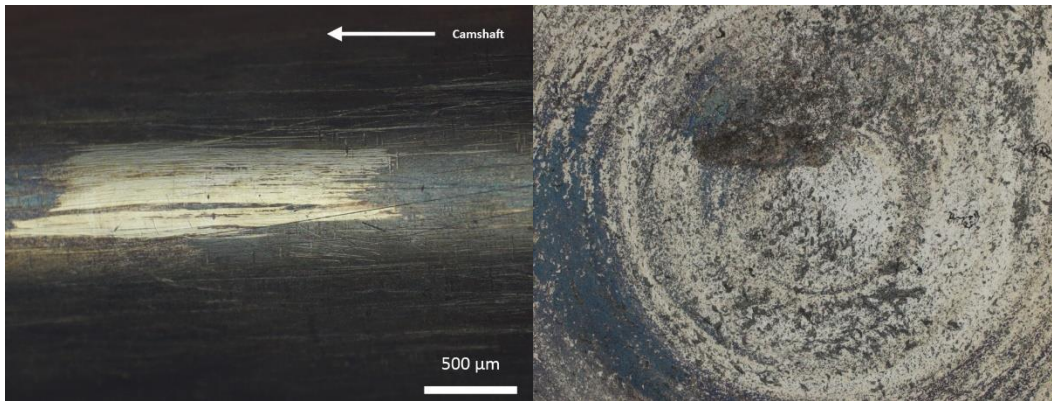
**Figure 49. Bright-field optical micrographs of plunger from pump 3 (fuel 1, 1800 h). Left, shaft; right, base.**

Bright-field micrographs of the plunger show the surface of the plunger in more detail (Figure 49). The majority of the surface was covered in the same dark-colored areas that were prominent in pump 2. The pump 3 plungers had more abrasive scratches than the pump 2 plungers. The scratches were primarily axially oriented, but many had some circumferential component. There were some areas where the discoloration is not present, as seen in the center of the left micrograph of Figure 49. The plunger base (right) had a slight brown discoloration with many dark-grey spots speckled across the surface.

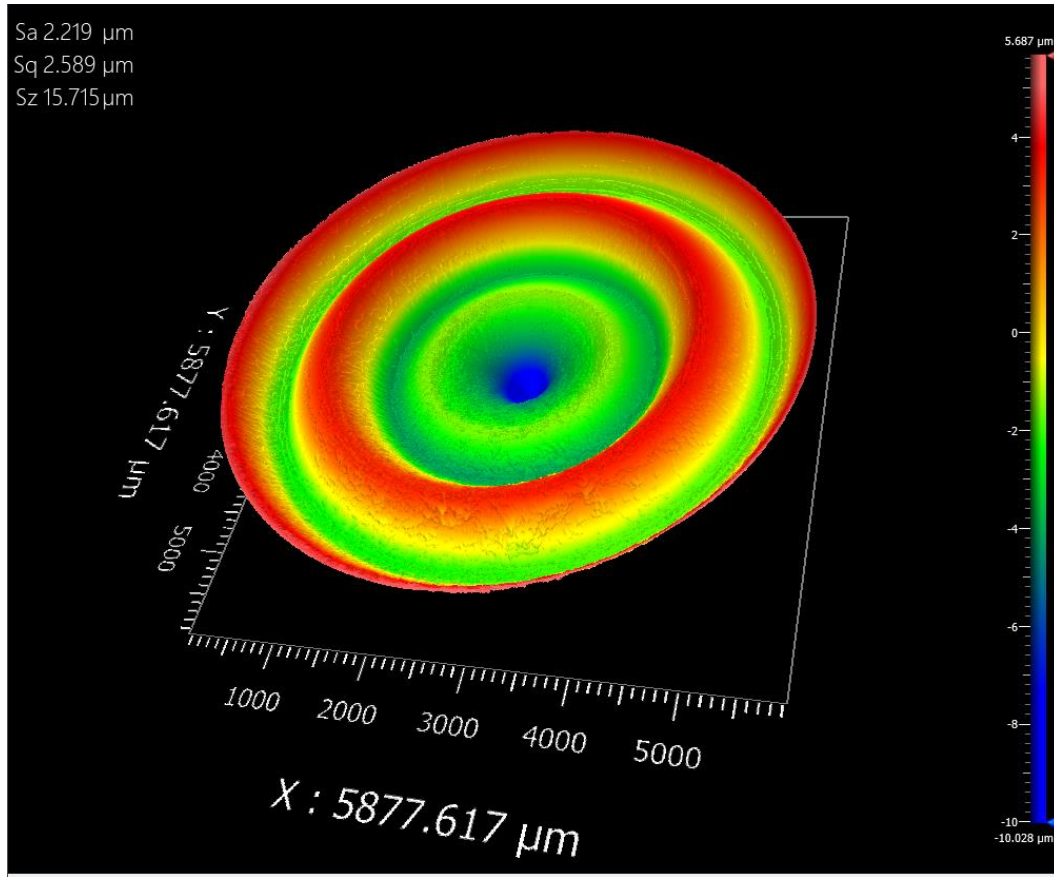
**Figure 50. Surface profile of plunger base from pump 3 (fuel 1, 1800 h).**

A surface profile of the base of the pump 3 plunger (Figure 50) revealed a wear pattern with circumferentially oriented wear marks, which made the surface resemble a surface of revolution. When compared to the profile of the interior raised surface of the pump 3 bucket, the plunger surface appeared to be the inverse pattern, having high points corresponding to low areas on the bucket. Similar to pump 2, the surfaces appeared to wear due to rotation of the bucket and plunger with respect to each other. By comparing the surfaces in pump 2 and 3, it can be seen there was some variability in the wear patterns indicating no location on the surface has

preferential wear. The roughness of the plunger base was  $S_a = 561 \pm 274$  nm. The roughness of the plunger shaft was  $S_a = 73 \pm 29$  nm.

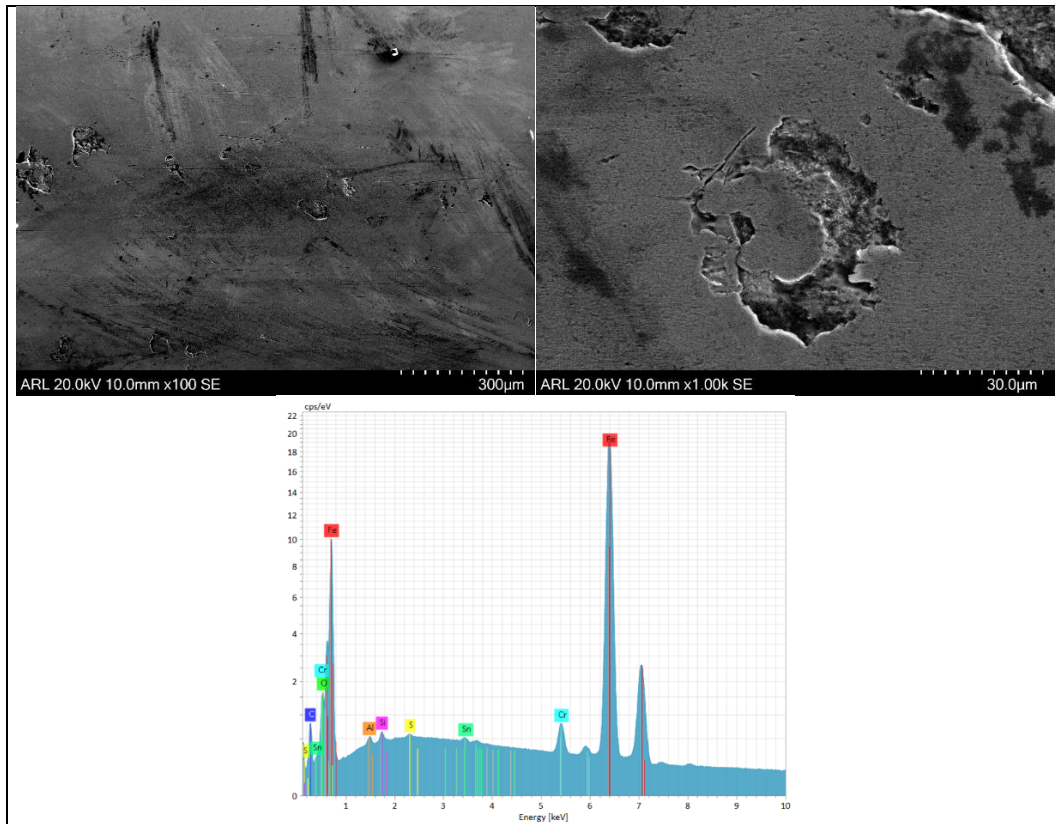
**Figure 51. SEM micrograph taken with SE detector at 100× (upper left) and 1000× magnification (upper right) and EDS spectra (center) of the plunger from pump 3 (fuel 3, 1800 h).**

The SEM micrographs (Figure 51) of the pump 3 plunger showed there were small pits that had formed on the plunger surface. These pits were approximately 20 to 40  $\mu\text{m}$  wide. The EDS spectra (Figure 50) showed that the composition was mostly iron with small amounts (<10%) of chromium and oxygen. The oxygen was observed in a much smaller quantity for the plunger than for the bucket.

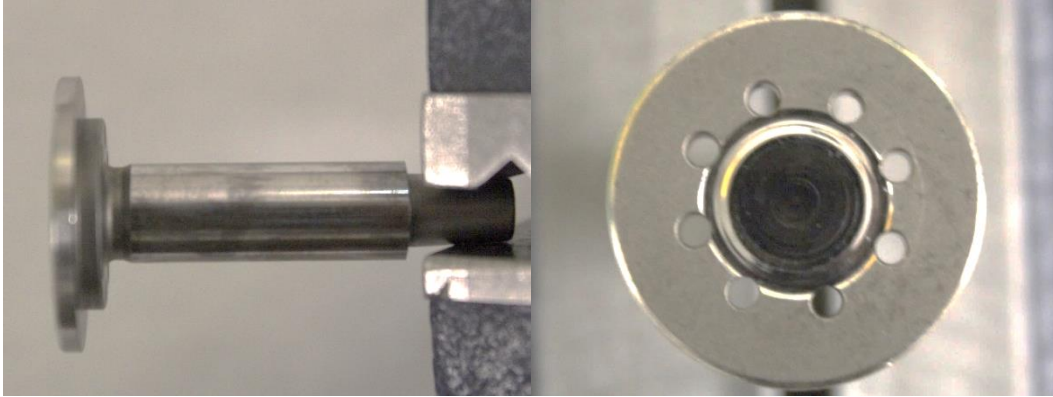
**Figure 52. Plunger from pump 4 (fuel 2, 476 h).**

The pump 4 plungers had significantly less discoloration than pumps 2 and 3 (Figure 52). Two marks were seen on the plunger, one near the tip and another towards the base. There were some circular wear marks on the base of the plunger.

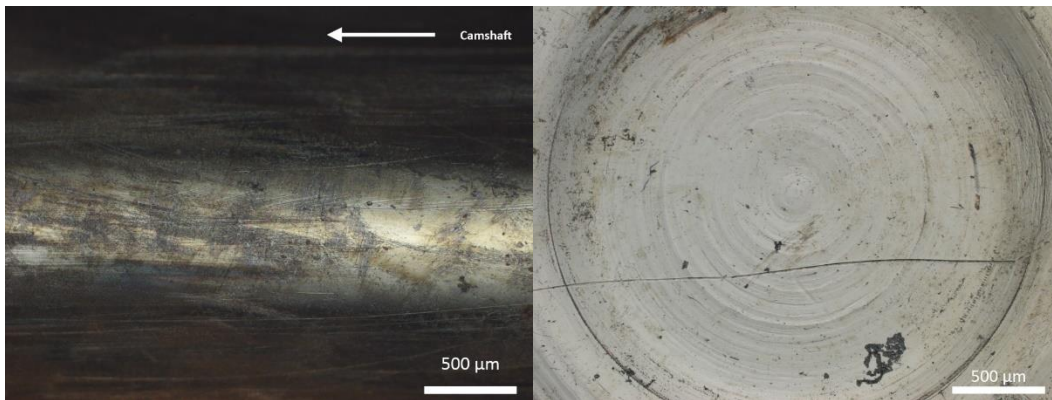
**Figure 53. Bright-field optical micrographs of plunger from pump 4 (fuel 2, 476 h). Left, shaft; right, base.**

Optical micrographs of the plunger are shown in Figure 53. The plunger had some patches of discoloration, although significantly less than in pumps 2 and 3. Several scratches were oriented primarily along the axial direction, suggesting that there may have been some abrasive wear, possibly from third-body particles. The plunger base was mostly smooth with some concentric grooves. A few brown spots were visible.

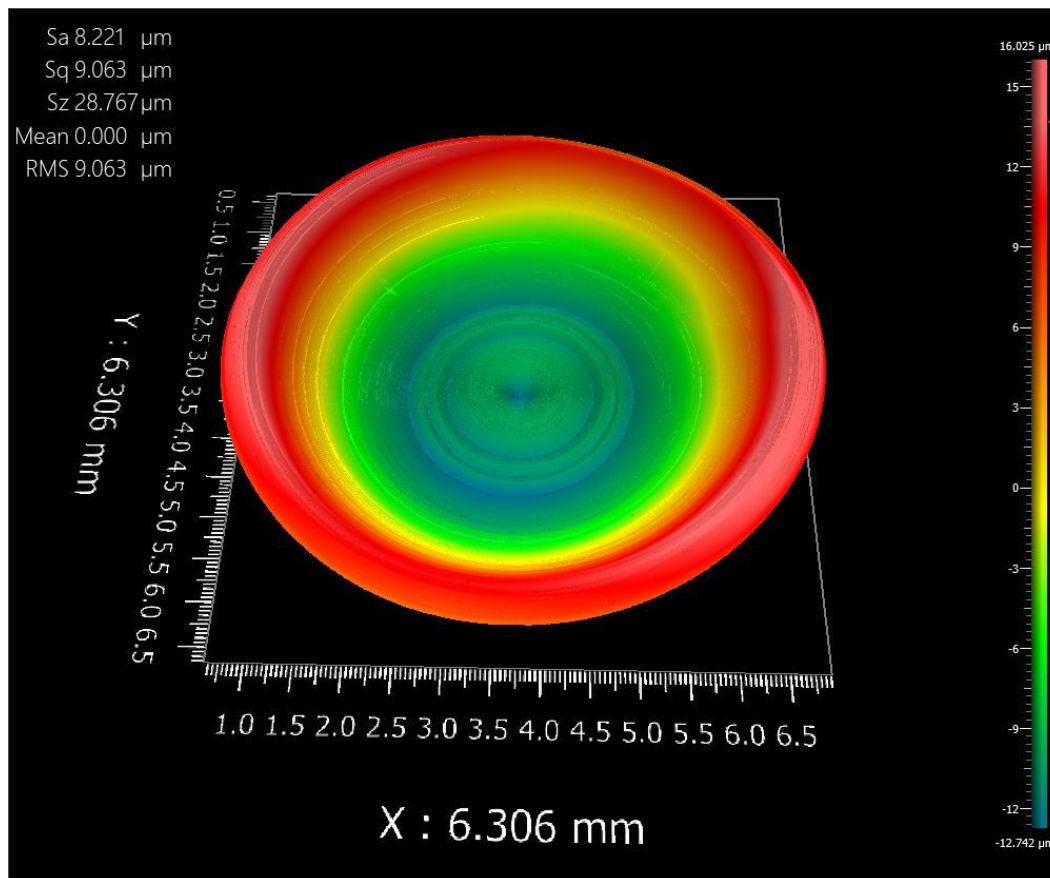
Figure 54. Surface profile of plunger base from pump 4 (fuel 2, 476 h).

A surface profile of the pump 4 plunger is shown in Figure 54. Similar to the other pumps, the pump 4 plunger had a wear pattern that appeared to be the reflection of the complementary surface in the bucket. The surface resembled a surface of revolution. The roughness of the plunger base was  $S_a = 249 \pm 82$  nm. The roughness of the plunger shaft was  $S_a = 72 \pm 10$  nm.

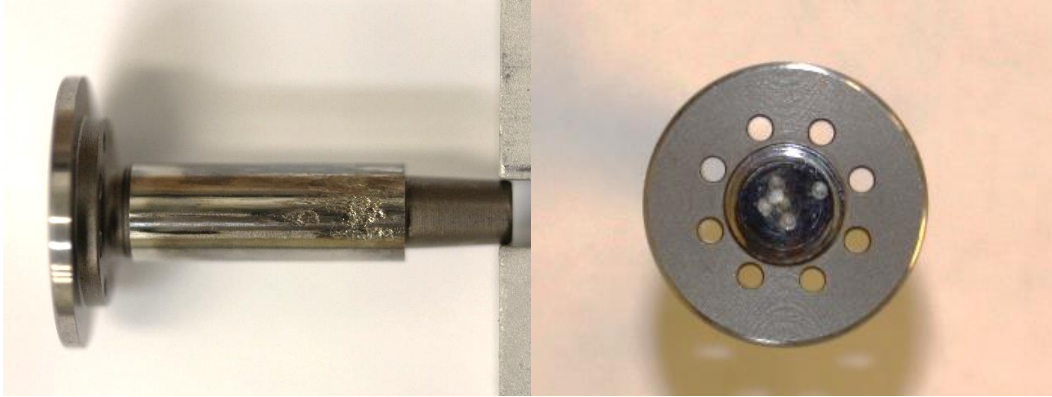
**Figure 55. Plunger from pump 5 (fuel 2, 1200 h).**

In pump 5, the plungers displayed some discoloration towards the base of the plunger where it contacted the edge of the housing bore. One of the plungers had a large area displaying scuffing damage on the surface, shown on the left of Figure 55. Scuffing is generally characterized by sudden and severe irreversible roughening and wear of the surface through gross plastic deformation of surface material and adhesion of counterface material. We conclude that the wear was due to scuffing because of the abrupt boundary between the scuffed and unscuffed surfaces and due to the very minor amount of wear in the unscuffed region. The base of the plunger had circumferentially oriented scratches and minor discoloration. The increase in plunger dimensions through scuffing was likely the cause for the seizure of the plunger and decrease in flow rate.

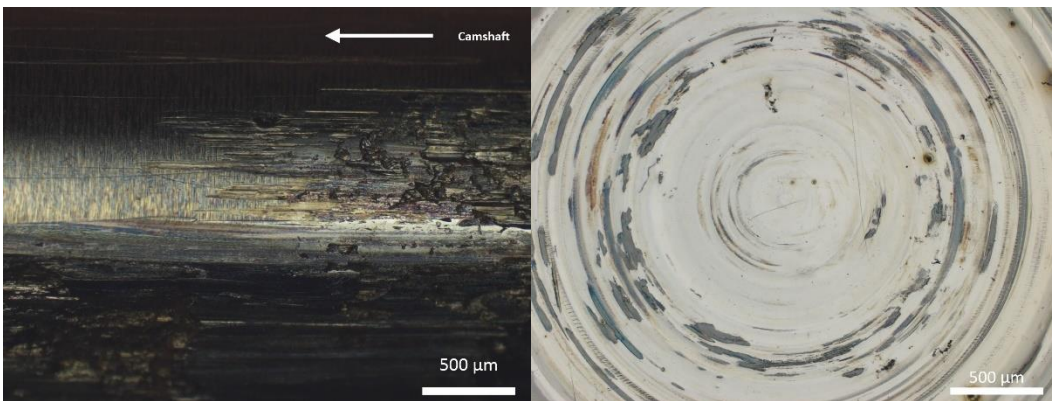
**Figure 56. Bright-field optical micrographs of plunger from pump 5 (fuel 2, 1200 h). Left, shaft; right, base.**

The bright-field micrographs of the plunger (Figure 56) show the details of the surface. The micrograph of the cylindrical portion of the plunger on the left of Figure 56 shows an unsuffed area on the upper left of the micrograph and a scuffed area on the right. In the unsuffed area, much of the original circumferentially oriented surface grind was visible. The surface had some discoloration, but it was much less than in the pump 2 and 3 plungers. This discoloration was limited to what appears to be the high points of surface, leaving the deepest crevices unchanged. In the scuffed area, the surface had large amounts of material removed and redeposited, which resulted in a significantly rougher appearance. Similar to the unsuffed surface, the scuffed area only had minor discoloration, limited to small areas of the surface. The plunger base had the same circular pattern as seen in pumps 2 and 4. Additionally, a few brown–grey spots were located on the surface.

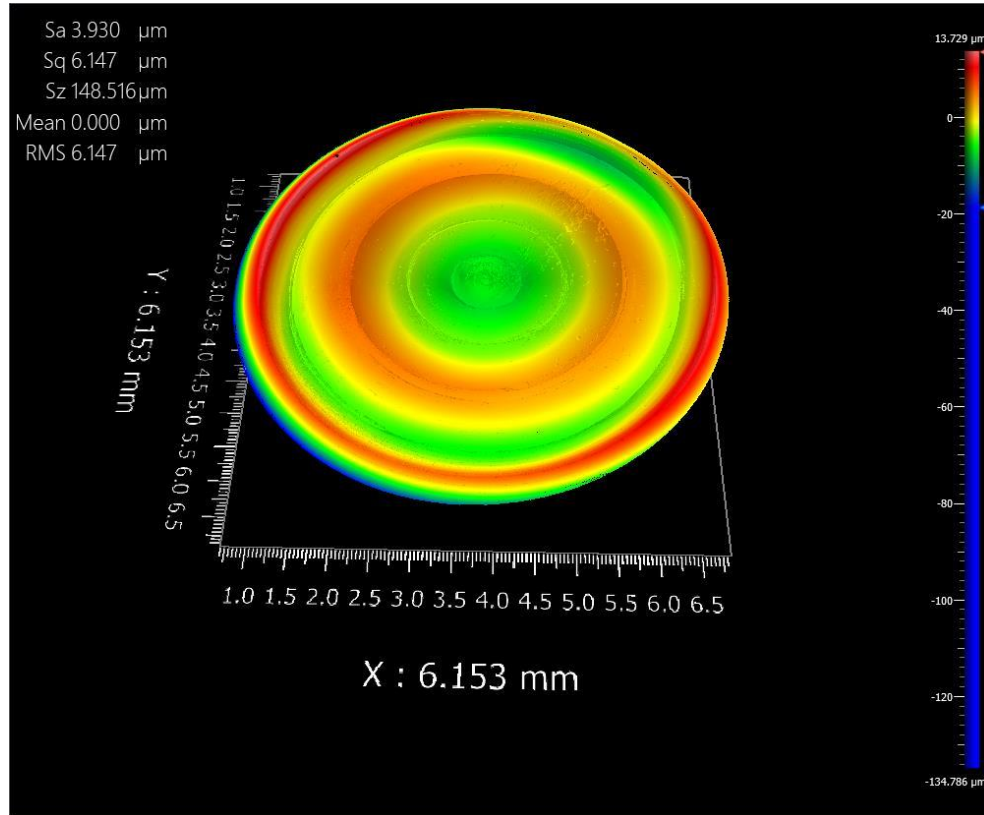
**Figure 57. Surface profile of plunger base from pump 5 (fuel 2, 1200 h).**

The surface profile of the plunger 5 base is shown in Figure 57. The profile of the plunger base had a similar wear to that seen in the other pumps. The roughness of the plunger base was  $S_a = 581 \pm 302$  nm. The pump 5 plunger had significant scuffing on part of the shaft, which resulted in much higher roughness within the

scuffed area. The roughness of the plunger shaft was  $S_a = 109 \pm 8$  nm outside of the scuffed area and  $S_a = 4896 \pm 3394$  nm within the scuffed area. The roughness outside of the scuffed area was higher than the pristine plunger shaft due to the large amount of abrasive marks.

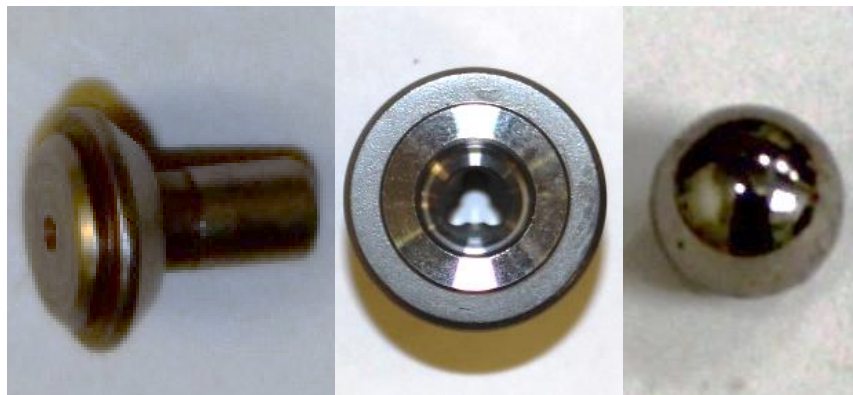
**Figure 60.** Inlet suction and outlet check valves from pump 1 (pristine, 0 h). Left, inlet suction valve; bottom center, inlet valve seat; right, check valve ball.

Figure 60 contains photographs of the inlet suction valve and outlet check valve. The inlet valve (Figure 60, left) has a narrow cylindrical section attached to a wider conical section. The cylindrical section is oriented towards the outside of the pump and sits within a bore in the inlet valve seat (Figure 60, center), while the conical section sits towards the inside of the pump oriented towards the plunger bore. The inlet valve seat has a cylindrical bore in the center with three notches towards the sides. The notches give the bore a clover-like shape. The inlet valve seat also has a conical incline away from the bore for the valve to sit flush against. When the valve is open, the fluid is allowed to move within the notches in the bore to get around the cylindrical portion of the valve, then in the gap between the conical portions of the valve and valve seat (Figure 61). When the valve is closed, the conical portions of the valve and valve seat form a seal to prevent inlet fuel flow during the high-pressure pump stroke. The pristine outlet valve (Figure 61, right) was a ball with an isotropic tumbled finish. The ball sits in a conical seat within the housing of the pump. Photographs were not taken of the outlet valve seat due to the difficulty of viewing it through the narrow passages.

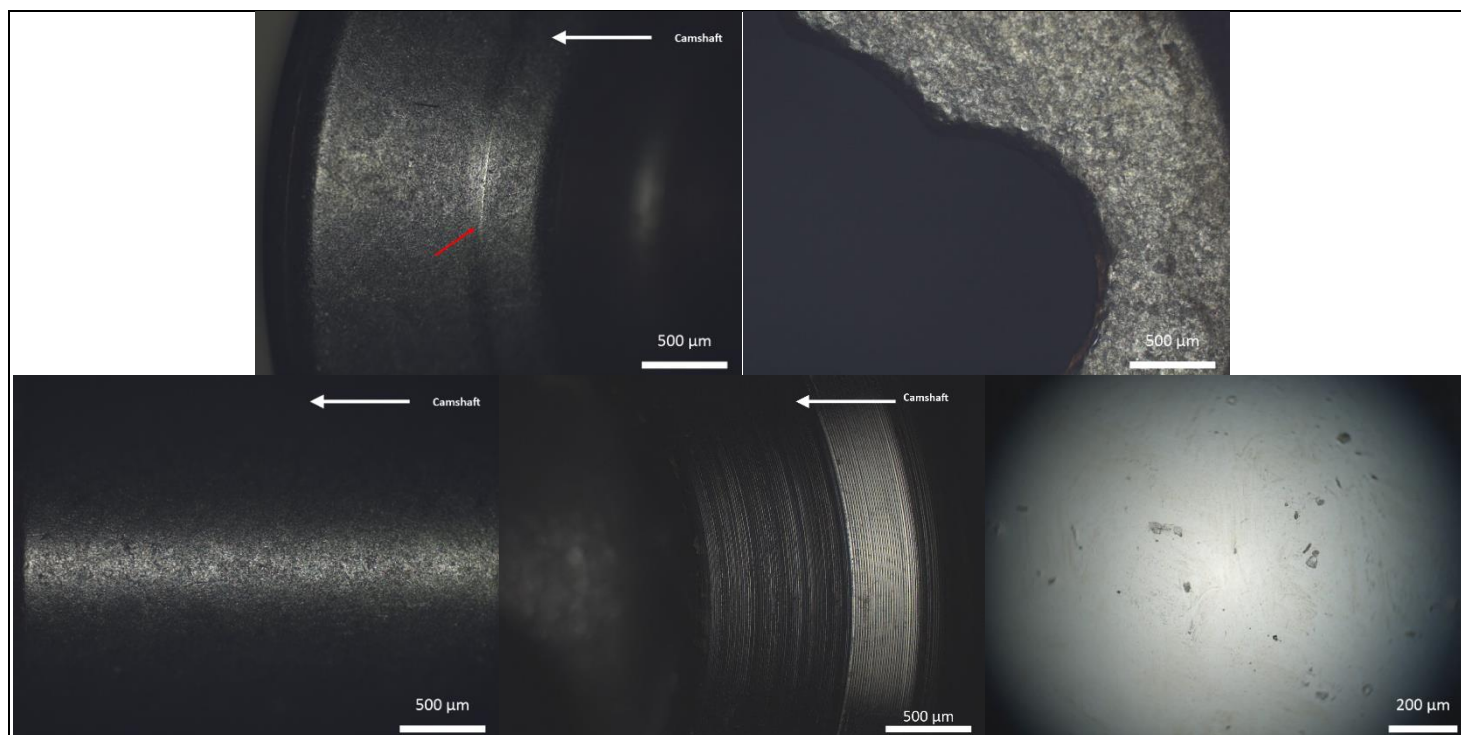
The surface finish can be seen more clearly in the bright-field optical micrographs of the valves and valve seat (Figure 62). The conical and cylindrical portions of the inlet valve (Figure 62, bottom left and top left) appeared to have an isotropic surface finish. A ring was observed next on the conical section where it mated with the inlet valve seat, as pointed out by the red arrow. The inlet valve seat (Figure 62, center) had a cylindrical grind within the inside conical surface that mates with the inlet valve. The outside of the inlet valve seat (Figure 62, top right) appeared to have a rough isotropic surface finish. The curvature from the center edge of the valve seat bore can be seen at the top left of the micrograph and one of the notches can be seen towards the center. The outlet check valve ball (Figure 62, bottom right) displayed a smooth surface with a uniform isotropic finish. A few 20  $\mu\text{m}$  pores were visible on the ball.

The hardness of the inlet valve seat was  $59.6 \pm 1.0$  HRC. The hardness of the inlet valve and outlet valve were not measured due to the size of the component.
