ARL-TR-10065 • MAR 2025

# Failure Analysis of High-Pressure Fuel Pumps Operated with Two Jet Fuels

by Nikhil Murthy, Caleb Matzke, Caleb McCoy, and Stephen Berkebile

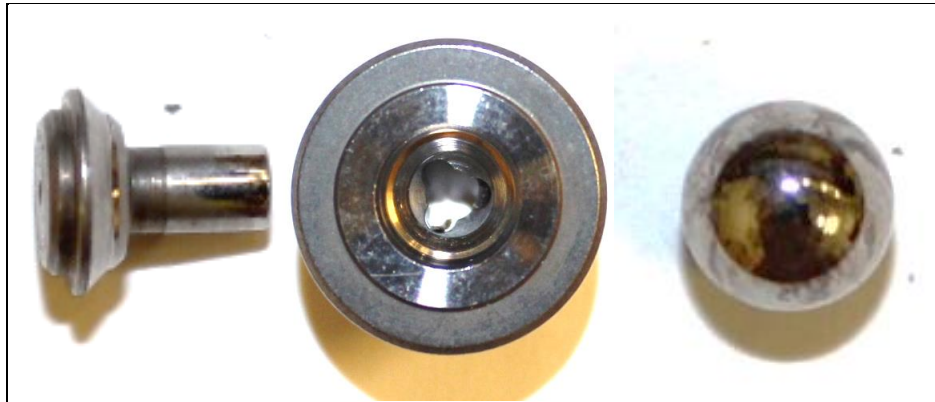
**Figure 63. Inlet suction and outlet check valves from pump 2 (fuel 1, 1052 h). Left, inlet suction valve; bottom center, inlet valve seat; right, check valve ball.**

In pump 2, several minor changes were observed in the inlet and outlet valves and inlet valve seat, however the forms of these components did not appear to have changed in a significant manner (Figure 63). The tips of the cylindrical portion of the inlet valves (Figure 63, left) appeared to be more polished, and there were some axially oriented abrasive marks along the tips. No significant change in the surface topography appeared further towards the base of the inlet valve of the conical portion. The inlet valve seat (Figure 63, center) similarly had not shown any significant signs of wear. The only observation was of some residue trapped in one of the inlet channels. The outlet valves (Figure 63, right) had discoloration of the surface, but there did not appear to be a significant change in roughness or form.

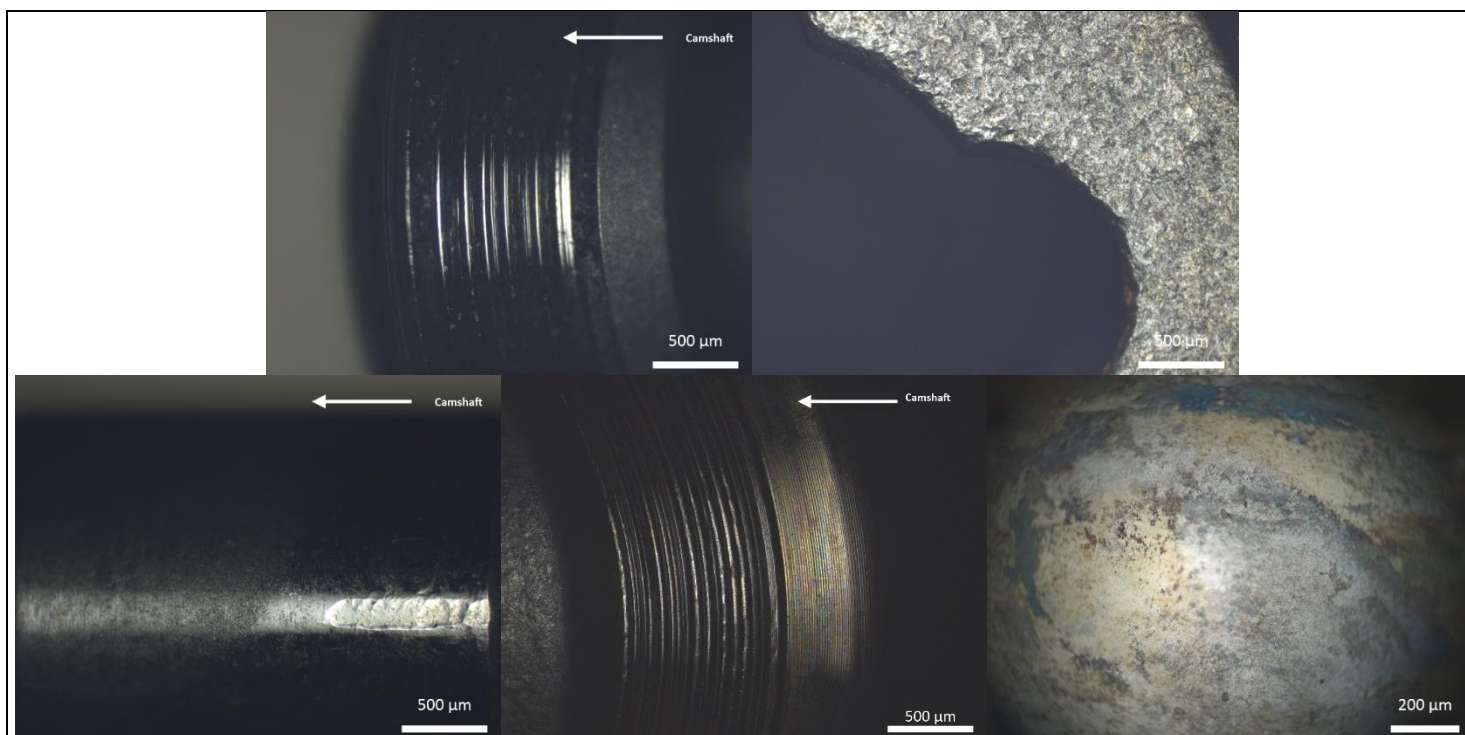
The changes in the valves and valve seat can be seen more closely in the bright field optical micrographs in Figure 64. The left-most micrograph shows the inlet check valve towards the tip of the cylindrical portion. The surface appeared to be relatively unchanged away from the tip and towards the conical section. The surface appeared to be smoother at the tip except for a small area that appeared scuffed. The scuff was approximately 0.2 mm wide and 1 mm long. Since the cylindrical portion of the inlet valve was not the sealing interface in the valve, it was unlikely to interfere with the function of the valve. However, the conical portion of the inlet valve is critical since it forms a sealing surface with the inlet valve seat. The conical portion of the inlet valve had many circumferentially oriented abrasive marks. This is likely due to wear from rotation of the valve relative to the valve seat during operation. Both the inlet valve and valve seat were free to rotate about their center axis. The inside of the inlet valve seat had several circumferentially oriented

abrasive marks, which appeared to be wider and deeper than the original grind, and a slight rainbow coloration was observed. The outside inlet valve seat appeared to be the same as it was in the pristine pump. The outlet check valve had patches on the surface that appeared discolored in a similar manner to the bucket and plungers from the pump, but the surface profile appeared to be mostly the same as in the pristine pump.

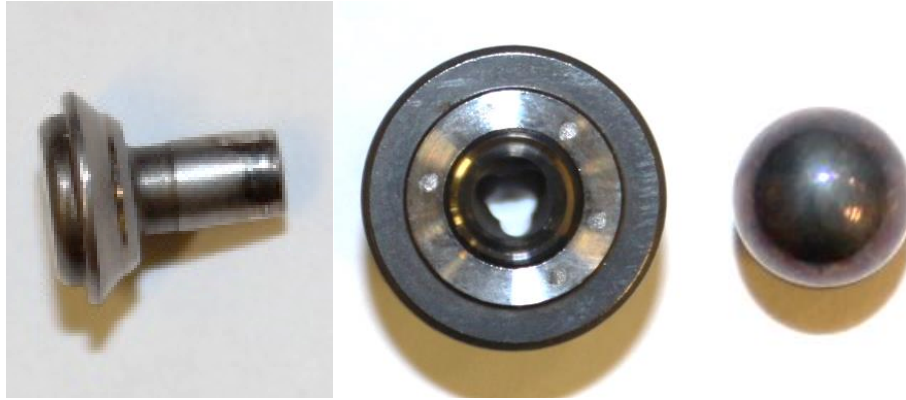
**Figure 65. Inlet suction and outlet check valves from pump 3 (fuel 1, 1800 h). Left, inlet suction valve; bottom center, inlet valve seat; right, check valve ball.**

The valves and valve seat from pump 3 had a similar appearance as those from pump 2 except they were significantly more discolored (Figure 65). The discoloration was particularly apparent in the outlet check valve.

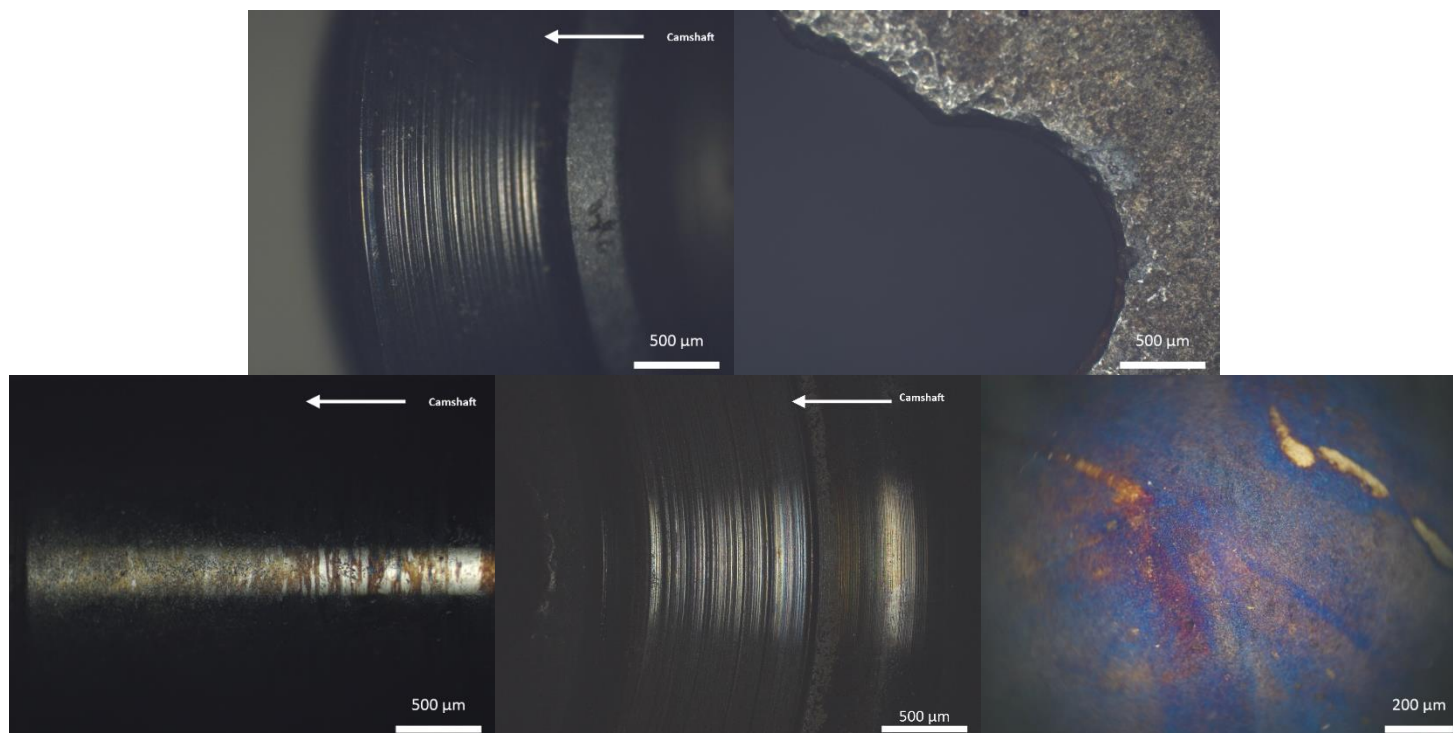
Bright-field micrographs of the valves and valve seat show the discoloration and wear in more detail (Figure 66). The inlet valve for pump 3 had patches of brown on the surface as opposed to the valve from pump 2. The inlet valve from pump 3 was smoother towards the tips of the cylindrical portion, similar to what was observed from pump 2. The inside of the inlet valve seat had circumferentially oriented grind marks and had a dark-brown coloration. The brown discoloration was also observed on the outside of the valve seat from pump 3, unlike from pumps 1 and 2. The outlet check valves appeared to be brown and blue. The discoloration in the valves is similar to the discoloration of the bucket and plunger, where a thin surface film may have formed.

**Figure 66. Bright-field optical micrographs of inlet suction and outlet check valves from pump 3 (fuel 1, 1800 h). Bottom left, conical section of inlet suction valve; top left, cylindrical section of inlet valve; bottom center, inside of inlet valve seat; top right, outside of inlet valve seat; bottom right, check valve ball.**

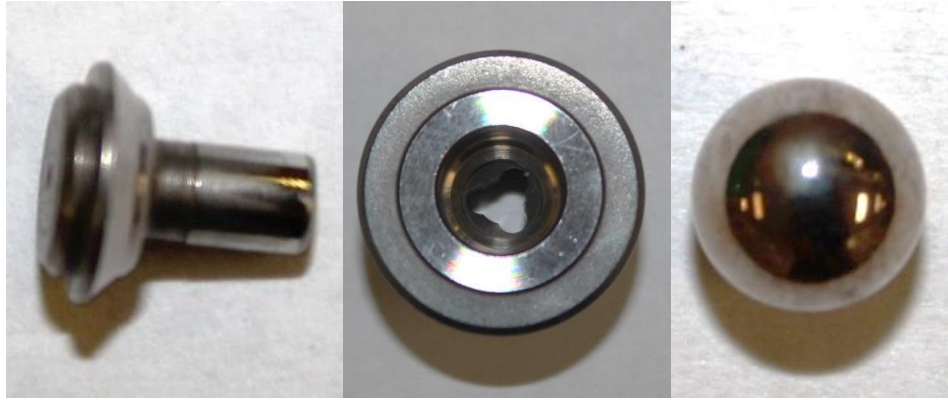
The inlet valve and valve seat for pump 4 did not have much discoloration, but the outlet valve did have minor discoloration (Figure 67). The inlet valve had a shiny appearance on the tip of the cylindrical section.

**Figure 67. Inlet suction and outlet check valves from pump 4 (fuel 2, 476 h). Left, inlet suction valve; bottom center, inlet valve seat; right, check valve ball.**

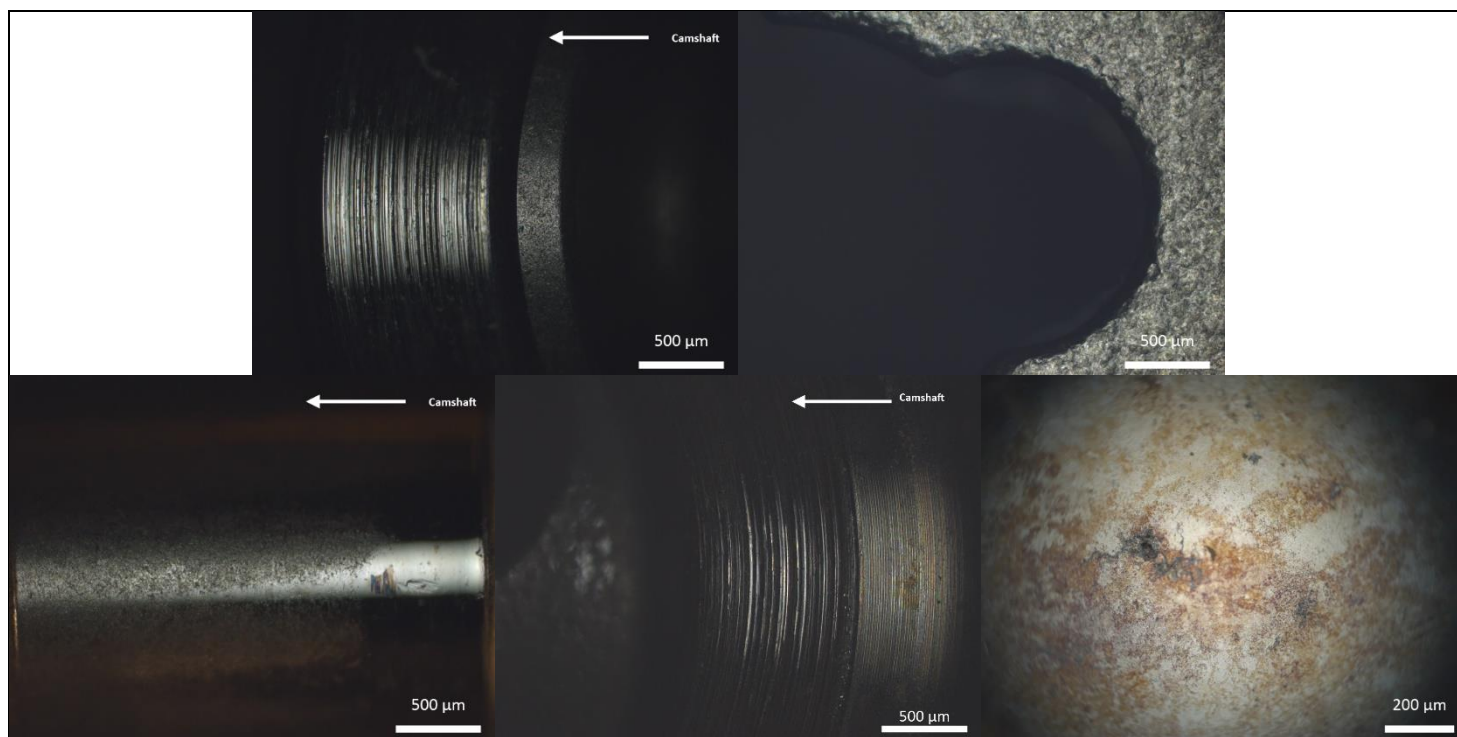
The wear of the pump 4 valves can be seen in the bright-field optical micrographs in Figure 68. The smoothed portion at the tip of the cylindrical portion of the inlet valve is approximately 0.7 mm wide. The conical section has many circumferentially oriented scratch marks similar to the other used pumps. The inside of the inlet valve seat had circumferentially oriented abrasive marks similar to pumps 2 and 3 but did not have significant discoloration. No significant change was observed between the outer surface of the pump 4 inlet valve seat and that of the pristine pump 1. The outlet valve ball can be seen to have some brown discoloration, although significantly less than in pump 3.

**Figure 68.** Bright-field optical micrographs of inlet suction and outlet check valves from pump 4 (fuel 2, 476 h). Bottom left, conical section of inlet suction valve; top left, cylindrical section of inlet valve; bottom center, inside of inlet valve seat; top right, outside of inlet valve seat; bottom right, check valve ball.

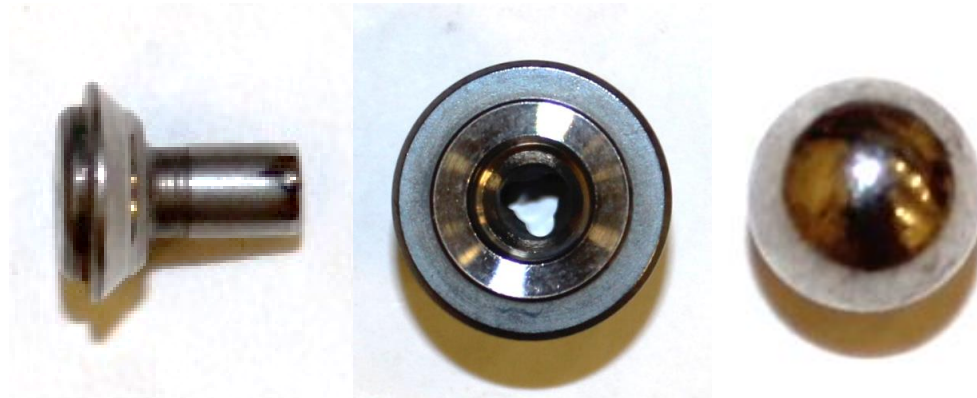
The valves and valve seat from pump 5 did not have any discoloration, but some wear was visible on the surfaces (Figure 69). The inlet valve had a shiny appearance on the conical portion. The inlet valve seat appeared unchanged. The outlet check valve had a slightly rougher appearance, and there was a ring-shaped depression on the surface.

**Figure 69. Inlet suction and outlet check valves from pump 5 (fuel 2, 1200 h). Left, inlet suction valve; bottom center, inlet valve seat; right, check valve ball.**

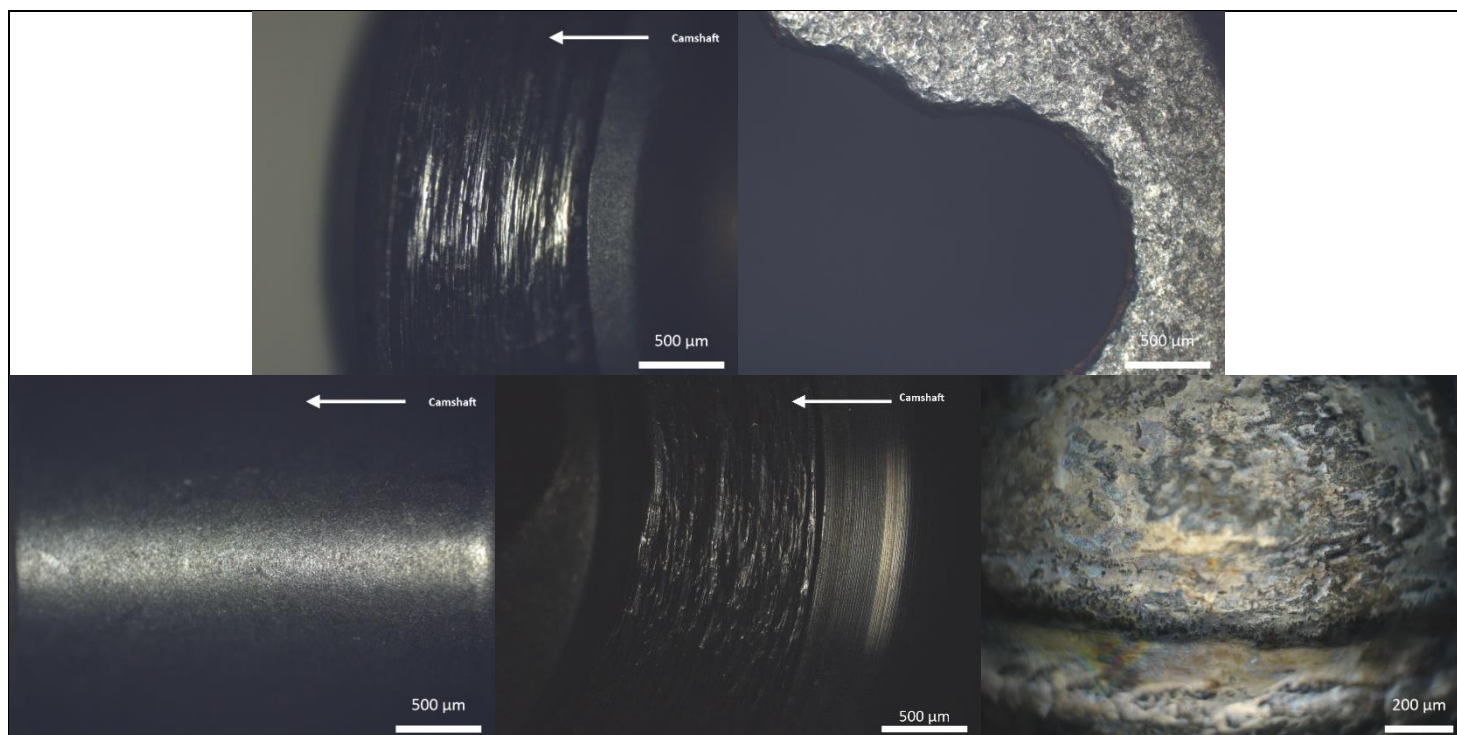
The wear of the valves from pump 5 can be seen in the bright-field optical micrographs in Figure 69. The conical portion of the inlet valve had a scuffed appearance along with many circumferentially oriented abrasive scratch marks. The wear on the conical portion of the pump 5 inlet valve appears to be much greater than the other pumps, however the cylindrical portion appeared to be similar in appearance to the pristine pump. The inside of the inlet valve seat had a scuffed appearance matching the conical section of the inlet valve, to which it mates. The outside of the pump 5 inlet valve seat was similar to the pristine pump except for flatter, shinier asperities. The abrasive scratches on the conical section of the inlet valve were likely caused by abrasion from the large asperities in the valves seat. The inlet valve and the valve seat fit together snugly despite the wear of the surfaces. The outlet check valve surfaces were significantly roughened, with depressions 20–100  $\mu\text{m}$  wide along the entire surface. In addition, the ring-shaped depression observed in Figure 69 appears as a large 100- $\mu\text{m}$  trench in the lower half of the Figure 70 micrograph.

**Figure 70. Bright-field optical micrographs of inlet suction and outlet check valves from pump 5 (fuel 2, 1200 h). Bottom left, conical section of inlet suction valve; top left, cylindrical section of inlet valve; bottom center, inside of inlet valve seat; top right, outside of inlet valve seat; bottom right, check valve ball.**
