ARL-TR-10293 • FEB 2026

# Predictive Corrosion Models to Mitigate Environmental Hazards on Ground Assets

| <b>14. ABSTRACT</b><br>Coating degradation on U.S. Army ground systems incurs significant maintenance cost. The objective of this proposed work is to develop a predictive Bayesian model for coating degradation and subsequent substrate corrosion on Army ground assets. With a better understanding of the root causes, steps can be taken to reduce corrosion impacts on Army materiel. In this effort, a model was created by incorporating significant analysis and learning from field surveys of over 15,000 assets and 250,000 components, coatings performance following standardized testing, and observations of coating conditions on fielded items. Model outputs will provide basic support to a Commodity Manager to determine optimal repaint intervals and minimize expenditures as well as assist in developing new products/processes beneficial to coating performance and yield increased life expectancy of an asset's protective coating systems. | | | | | |

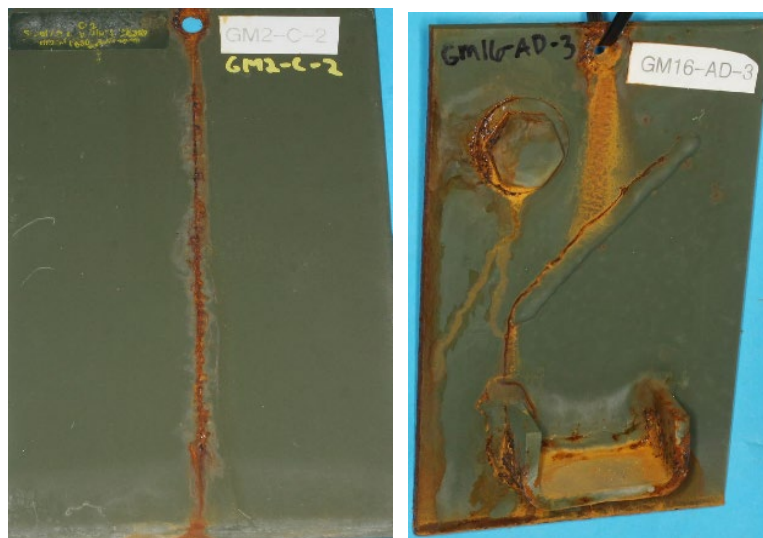
**Figure 7. Scribe panel vs. complex panel, 40 cycles GMW14872,<sup>5</sup> CARC.**

The results from the scribe analysis also provided a basis for estimating the SoC on complex surfaces compared with flat panels with an intentional defect. Complex surfaces with structures normal to the general surface or inherently creating crevices on the surface are more likely to have coating defects and corrode more rapidly (Figure 7).

The impact of complex surfaces was derived from a work examining the analysis of exposure data from a large panel set of both flat and complex panels exposed to GMW14872<sup>5</sup> cyclic corrosion testing.\* Panels from 40, 80, and 120 cycles were evaluated for SoC across various CARC systems. The average increase in the population with a SoC2, SoC3, or SoC4 rating was nominally 50%, considering scribes on flat panels versus complex surfaces in the same exposure. This factor

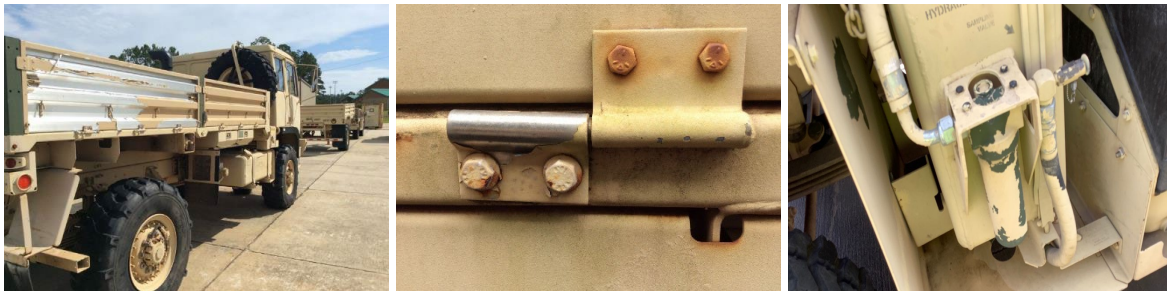
Paint delamination was often noted on the 41,664-part assemblies rated. A total of 22% (8,962) of the parts showed some coating delamination. Only 3% (1,319) showed delamination and an S.SoC; only 9% (3,705) showed delamination and any form of corrosion. This seems to suggest that delamination phenomena are not associated with the corrosion observations, yet it occurs in 22% of the parts. Figure 19 shows a normal distribution plot of these findings segregated by the maintenance classification. Increased delamination appears to differentiate (albeit weakly), compared with the S.SoC count (Figure 19), with the higher levels of recommended maintenance. Figure 20 shows a range of delamination observations, from large

areas to smaller areas on components. Some delamination occurs at the substrate and other delamination events are observed at the interface of separate coating layers. Much of the delamination occurs over stainless steel and aluminum substrates, known for their corrosion resistance compared to carbon steels, hence the lack of correlation to corrosion.

Figure 20. Examples of delamination (cargo bed side, hinge, hydraulic line).

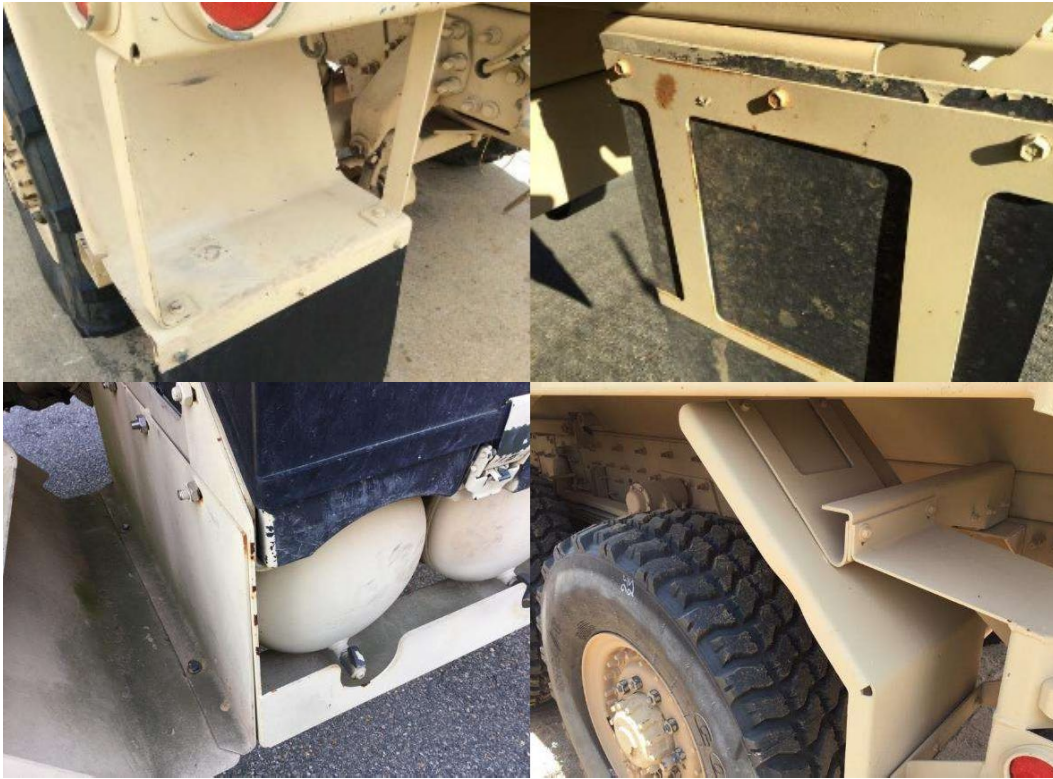
**Figure B-1. Brackets.**

The following pages present photographs of key part assemblies that show the style and complexity of the surfaces inspected.

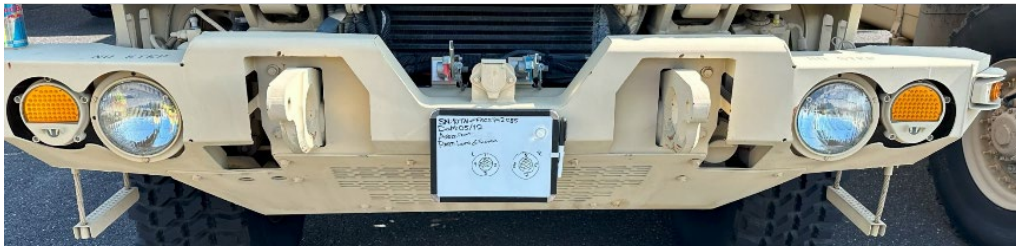
- 8 DFT locations
- No holiday testing

**Figure D-1. Lights and signals.**

The analysis of the detailed Fort Dix, New Jersey, data is intended to better support the root causes of any S.SoC observed. Appendix D provides a summary of the physical areas on the FMTVs that were inspected for DFTs and holidays.

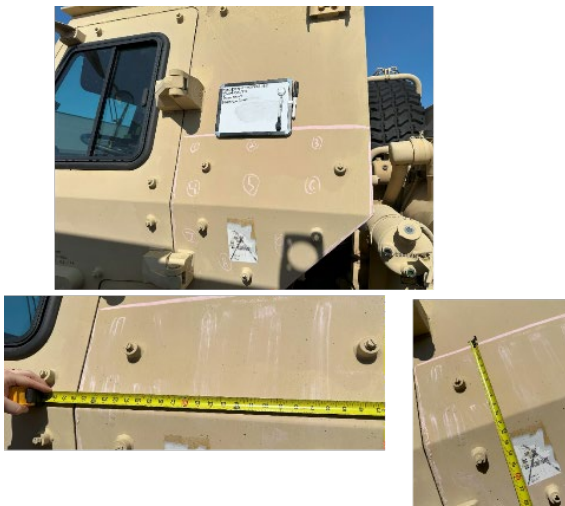
- 9 DFT locations
- Area = 532 in<sup>2</sup>
- Holiday edge length testing 37 in (red line)

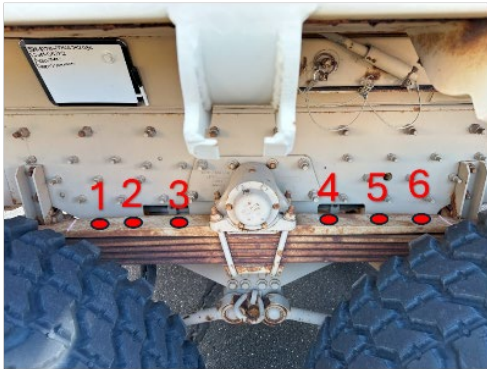
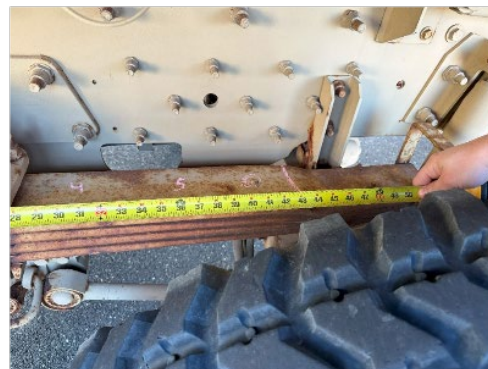
**Figure D-7. Suspension.**

- Area = NONE
- Holiday edge length testing 97 in (red line)
- Both sides and U cut-out in center

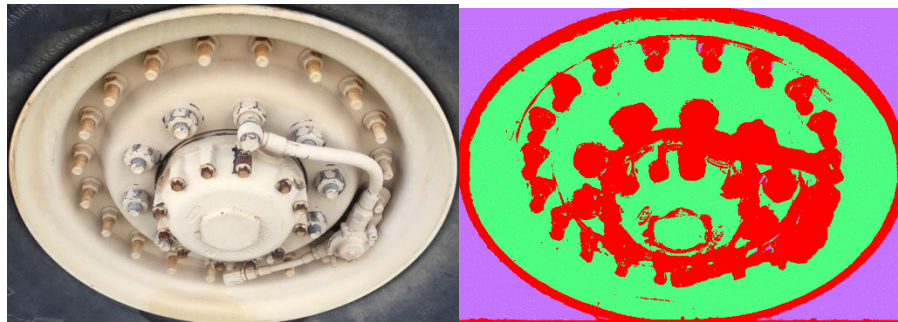
(purple = background, red = complex features, green = flat areas).

**Figure F-1. ImageJ analysis of wheels and lugs.**

We determined the Edge-to-Flat surface area ratio by using a combination of ImageJ analysis and visual analysis. We started by using ImageJ software to analyze several photos of each assembly type (Figures F-1 to F-3). The images were segmented utilizing the ImageJ software to select edges and complex areas in one color and flat areas with no complexities in another. Any background was selected in another distinct color. The results were analyzed to determine the ratio of the complex area to the noncomplex area using ratio of colors and provided a complexity ratio (complex/nocomplex). Several photos of each assembly type were analyzed, and the average determined.

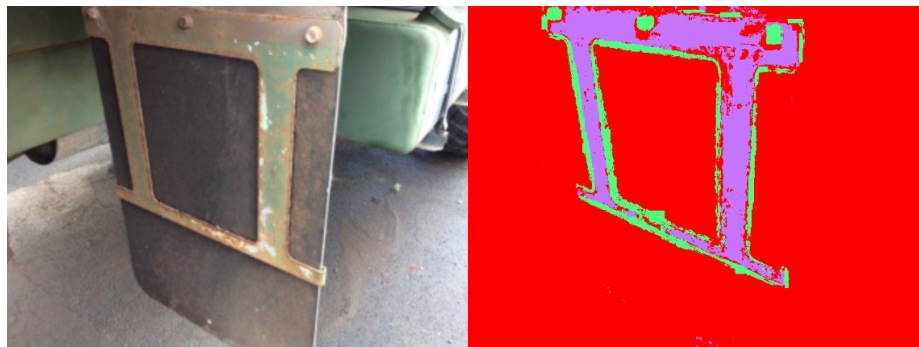
(red = background, green = complex features, purple = flat areas).

**Figure F-3. ImageJ analysis of one type of bracket.**
